Wisconsin's Cross-Planked Mosquito Fleet:
Underwater Archaeological Investigations
of the Scow Schooners
Iris, Ocean Wave, and Tennie and Laura

State Archaeology and Maritime Preservation Program
Technical Report Series #06-001

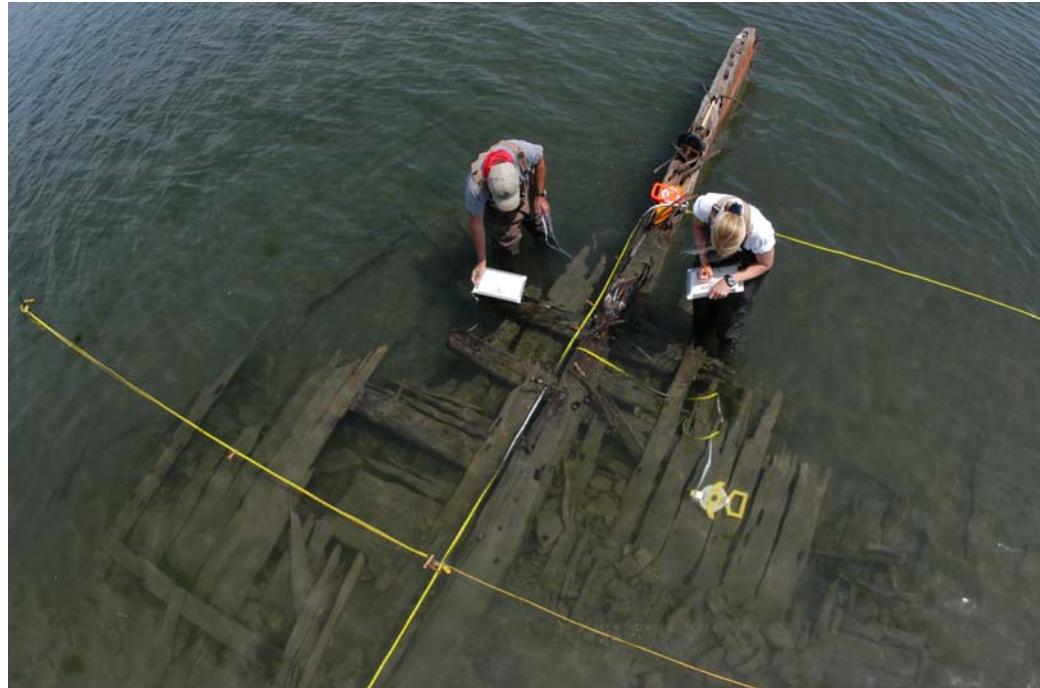
The stern is the most exposed hull section, from the rudder shoe forward 24 feet, where the hull disappears into overburden. The rudder shoe is an iron plate 5 inches square, fastened with a nail in each corner. The shoe rides atop a timber 3 feet in length that is hook-scarphed into the underside of the keel, a repair from either damage or wear. A 4 in. by 1/2 in. iron reinforcing strap wraps around the end of the shoe timber. The sternpost is missing, but two deadwood timbers are extant to where they abutted the sternpost 1 ft. 11-1/2 in. forward of the rudder shoe. The deadwood timbers are fastened to the keel with 3/4 in. iron through bolts. The deadwood rises above the water's surface and is badly weathered, making dimensional measurements problematic. All cant frames are missing, and no cant frame pockets are visible. The first floor timber is located 14 ft. 5 in. forward of rudder shoe. Few intact frames are visible; those that are measure 4 in. molded by 7 in. sided, with 11 in. spacing. The vessel appears to be single framed; however, highly deteriorated remnants of a second timber are fastened to the after side of the third and fourth floors from the stern. These timbers are significantly more deteriorated than the floor timbers, suggesting they were constructed of a different wood than the floor timbers and later added as a repair to reinforce the floors (Figure 8). Limber holes are cut into the starboard side floors only, 5 in. from edge of the keel, measuring 2 in. wide by 1 in. high. The keelson begins 12 ft. 10-3/4 in. forward of the rudder shoe and is 12 in. sided by 7 in. molded. A badly eroded rider keelson begins 3 ft. 2-3/8 in. forward of the keelson's after end, measuring 12 in. sided by 4 in. molded. Through bolts that fasten the keel assembly protrude 5 in. above the rider's upper face. Keelson assembly through bolts are both 1/2 in. and 3/4 in. diameter with no evidence of clinch rings.

Figure 8. Exposed stern section, facing aft. Photo by Tamara Thomsen.

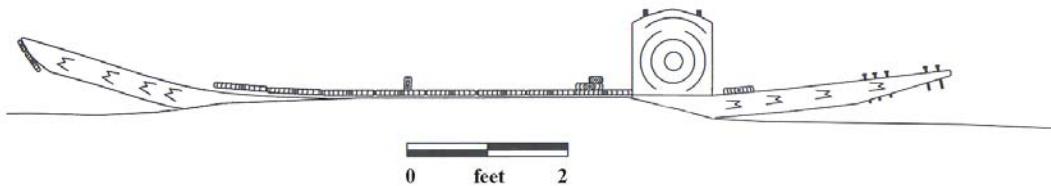
A cross-section detail was taken 20 feet forward of the rudder shoe. At this location the port side hull extended 8 ft. 3-5/8 in. from the vessel's centerline, and 3 ft. 6 in. to starboard of centerline. The measured deadrise was unequal between sides (Figure 9). The starboard side exhibited a deadrise of 5-1/4 in. over a 3 ft. 5 in. span. The port side has less deadrise, with a flat floor that extends 4 ft. 4 in. from the vessel's centerline before beginning a gradual angle towards the turn of the bilge, rising 8-3/4 in. over the last 45 in. of frame. All visible framing is athwartships, typical of conventional schooners. Frames at the turn of the bilge exhibit a soft chine with no evidence of a chine log, king posts, or cross-planked hull (Figure 10).

Figure 9. Hull cross section, facing forward.

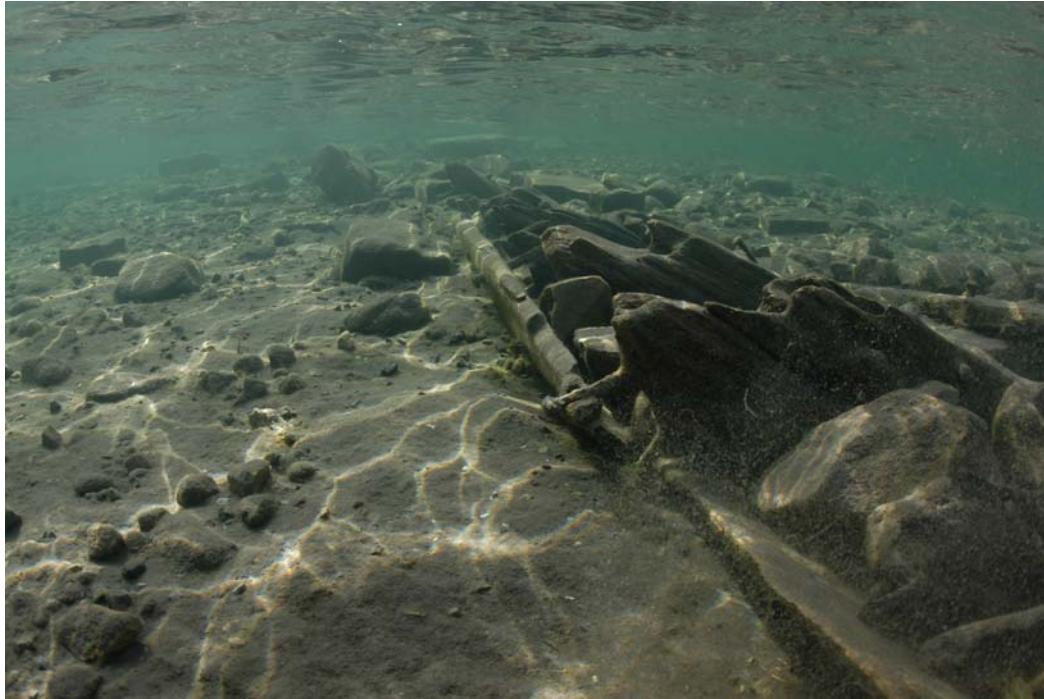
Ceiling and outer hull planking are present on both port and starboard sides, but are in little better condition than the frames and deadwood. Ceiling plank thickness averages 3/4 in. on the port side and 1-1/4 in. on starboard. Ceiling plank width on the port side varies from 4-1/4 in. to 7-1/4 in., and from 6 in. to 7-3/4 in. on starboard. Outer hull planks average 2-1/4 in. thick, and vary in width from 2-3/8 in. to 9-5/8 in. on the port side, and from 7-1/4 in. to 9-5/8 in. on starboard. Planking is fastened by two sizes of chisel point, rose-head nails 5 in. long by 3/8 in. square, and 7 in. long by 1/2 in. square.

Figure 10. Frames and outer hull planking at the turn of the bilge, port quarter.
Photo by Tamara Thomsen.

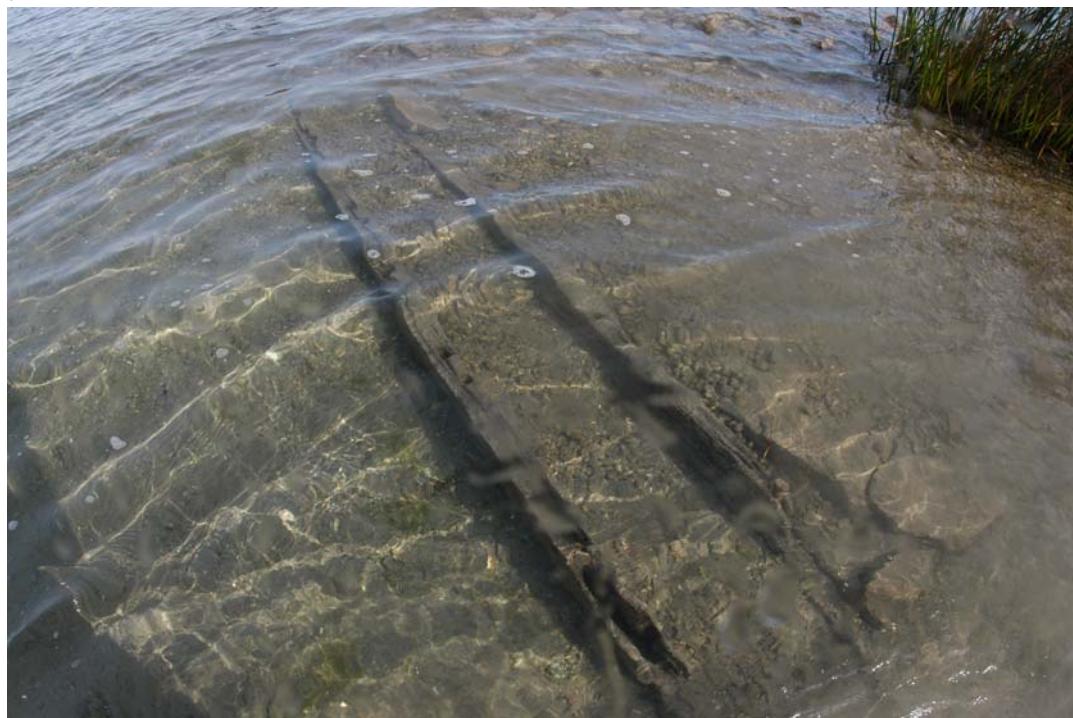
Figure 11. Centerboard trunk, facing aft. Photo by Tamara Thomsen.

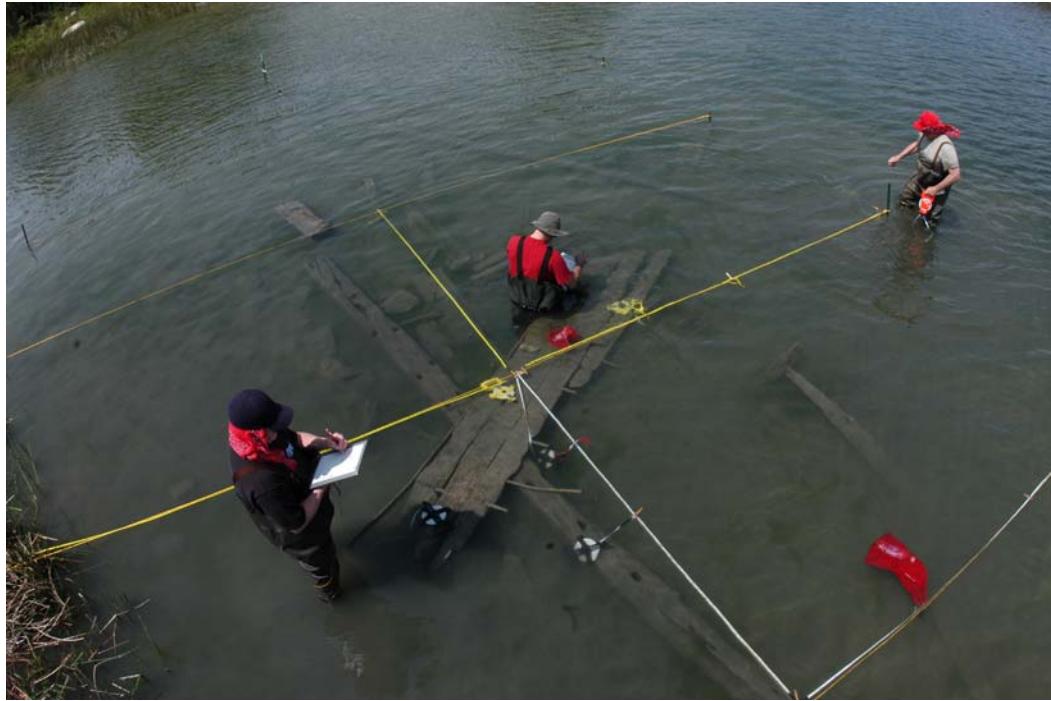
The centerboard rests atop the rider keelson, which also migrates about the site (Figure 12). During a site visit the previous fall the rider keelson was replaced atop the keelson from several feet away, aligned on the keel bolts. When WHS archaeologists returned in June 2005, the rider keelson had again moved to its present location to port of the keelson. The rider keelson measures 9 in. sided by 7 in. molded and 22 ft. 8 in. in length. A step is visible on the forward end, measuring 1 ft. 4 in. long by 4-1/2 in. wide and 3 in. deep. The step's inner mortise measures 6 in. long by 2 in. wide and passes completely through the rider. This step is 5 ft. 2 in. from the rider keelson's forward edge. Compared with historic photographs, this step is for the sampson post rather than the foremast. Historic images place the foremast approximately 10 feet aft of the stempost, with sampson post approximately equidistant between the two. No other steps were visible. The keelson is buried in rock and mud, but a 5 in. wide by 2 ft. 6 in. long section of stem iron protrudes from the keel's underside. A 3 ft. 6 in. long disarticulated stempost fragment lays near the end of the rider keelson. Eight inches sided by 9 in. molded, rabbets are visible on either side of the post. Off the starboard bow is a sail boom 25 ft. 8 in. long and 6 in. in diameter. The boom jaws are absent, but its shelf extends 5 feet from the boom's forward end. Compared with historic photographs, the boom's length suggests it was the foremast boom.

Figure 12. Bow section of wreck site facing forward. Centerboard lays atop rider keelson. Stempost section is visible just forward of rider keelson. Photo by Tamara Thomsen.

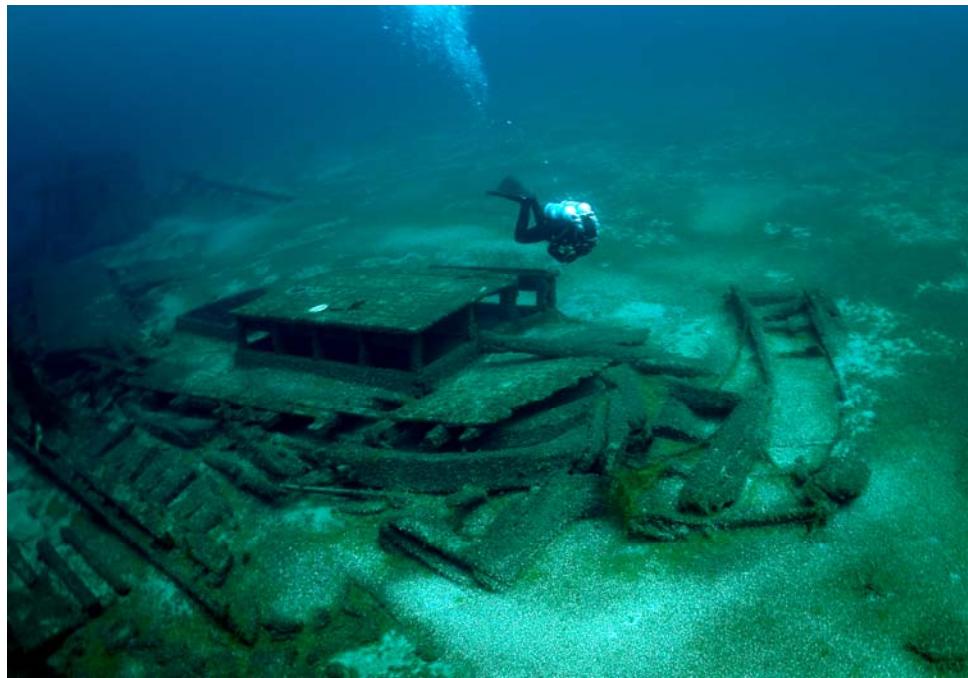
When the *Ocean Wave* struck the bottom she broke her back just aft of the centerboard trunk. The aft cargo hatch, stern cabin and decking, transom, and rudder lie to starboard at an 18 degree angle from the vessel's centerline (Figure 18). The keelson's after end is visible beneath the rear deck and rudder, lying parallel and centered with the aft wreckage and measuring 1 ft. sided by 1 ft. 9-5/8 in. molded. The transom and several feet of stern ramp have fallen away from the hull and are partially buried under several inches of sand. Transom width is 15 ft. 6 in., with a curvature radius of 10-3/4 in. The transom's rail cap measures 7-1/4 in. wide by 2-3/8 in. thick, and has an open chock on either quarter. The chocks are 1 ft. 8 in. long and 7-1/4 inches square, with a 3-5/8 in. opening centered on the chock. The two outermost transom frames are 4-3/4 in. sided by 2-3/8 in. molded; inner frames are slightly smaller at 3-5/8 in. sided by 2-3/8 in. molded. Spacing between the outermost and first inner frame is 2 ft. 4-3/4 in., but narrows to 2 ft. on all inner frames. Transom frames continue uninterrupted from the rail cap to below deck where they are broken approximately 3 ft. below deck level. Much of the transom's and stern ramp's inner planking is missing. Only fragments attached to the frames just below deck level and just below the rail cap remain. Stern ramp ceiling planking is 6 in. wide by 1-3/4 in. thick. Inner bulwark planking is a narrower 4-1/4 in. Transom outer hull planking measures 4-1/4 in. wide and 1-1/2 in. thick, and continues below deck level onto the cross-planked stern ramp.

Figure 18. *Ocean Wave*'s transom, rudder, aft deck, and cabin. Photo by Tamara Thomsen.

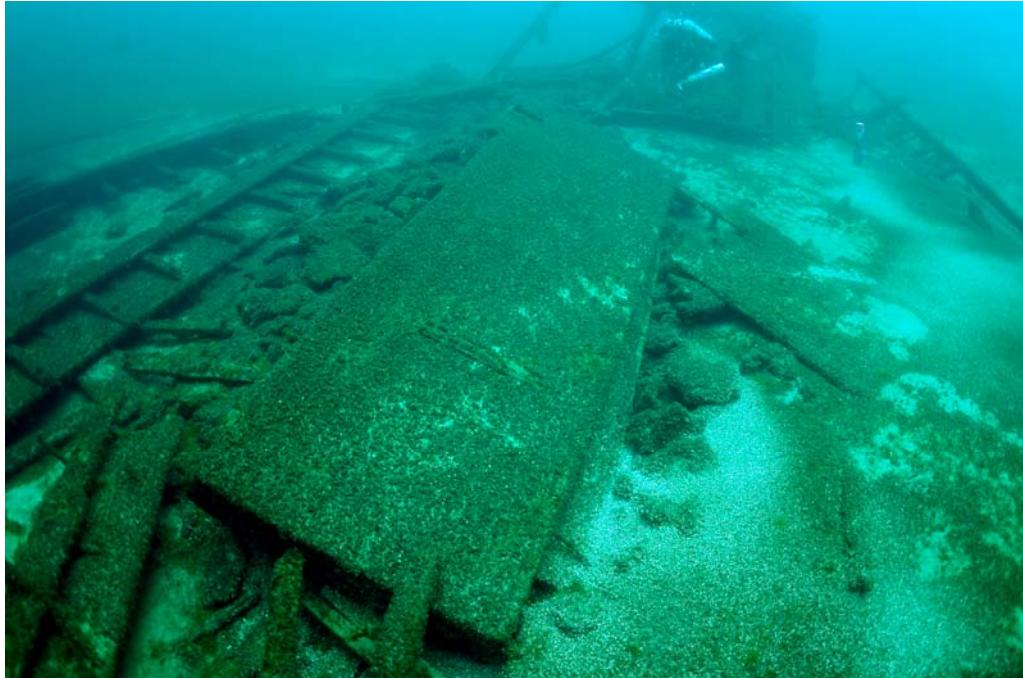
The centerboard trunk lays along the vessel's centerline but has fallen to the port side (Figure 19). The trunk measure 20 ft. 1-1/4 in. long by 6 ft. 4-3/4 in. tall, by 1 ft. wide. The trunk is longitudinally-planked with six planks. Widths (from top to bottom) measure 1ft. 3-5/8 in., 1 ft. 2-3/8 in., 10-3/4 in., 10-3/4 in. 1 ft. 1-1/4 in., and 1 ft. 3-5/8 in. All planks are 3-5/8 in. thick and fastened on either end by three 5/8 in. bolts with 1-3/4 in. clinch rings on either end. Bolts are fastened in a triangular pattern that does not alternate from plank to plank. The centerboard is in a retracted position, protruding six inches from the trunk's aft end. The centerboard is 3-5/8 in. thick, and its leading edge is rounded with a shoulder on either side, suggesting a tongue-in-groove joint with one or more planks missing. The centerboard pivot pin has been dislodged and lays atop the trunk near its former position. The centerboard's pivot hole is 3 ft. 4-3/4 in. on center from the trunk's forward end, and 1 ft. 9-5/8 in. on center from the trunk's lower edge. The pin measures 1 ft. 1-1/4 in. long with a 2-3/8 in. shank. One end is peened onto a washer 4-3/4 in. in diameter. The shank's end opposite the washer has a slot for a forelock pin that is 1-1/4 in. long by 1/4 in. wide, 1/2 in. from the shank's end. The keel, covered by cargo and sand, was not visible beneath the centerboard trunk. A section of decking protrudes slightly from the bottom to the starboard side of the centerboard trunk. Eleven deck planks are visible, averaging 7-1/4 in. wide.

Figure 19. Centerboard trunk with centerboard protruding from bottom. Photo by Tamara Thomsen.

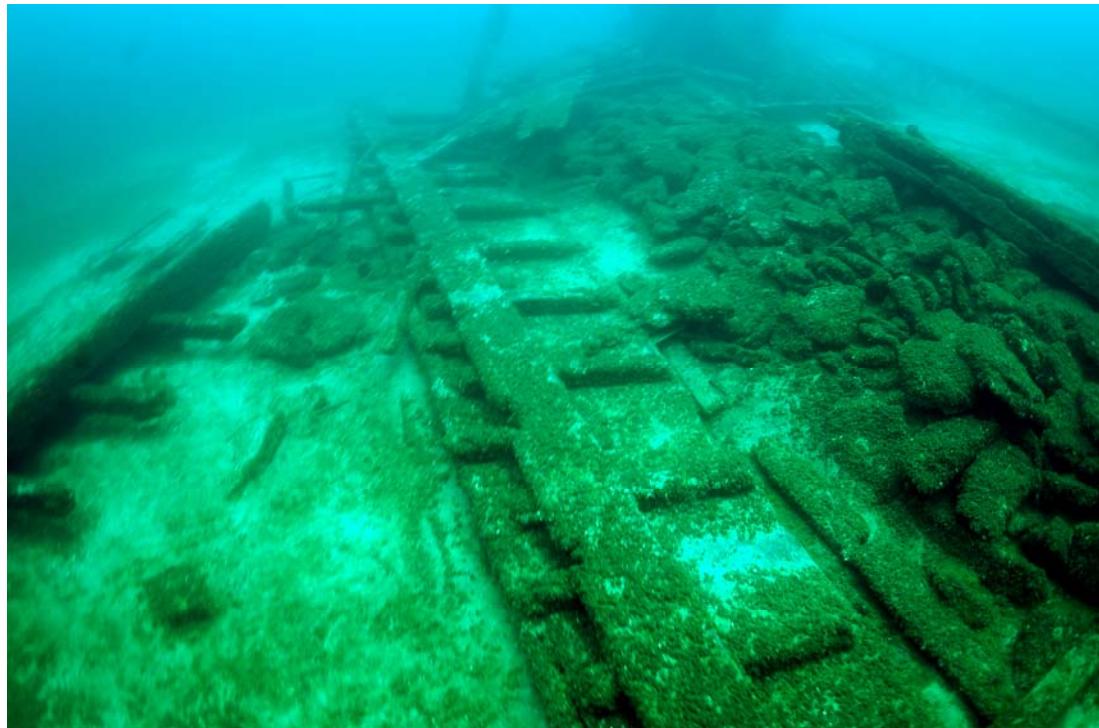
It appears the *Ocean Wave* borrows from a variety of construction techniques, being somewhat of a cross between gunnel-built and traditionally framed vessels. The outer hull is longitudinally planked and measures 2-3/8 in. thick. Evidence of edge-bolting is visible at the hull break, but it was impossible to determine bolt spacing or how many planks the bolts passed through. Remnants of a chine log are visible along a short hull section, but is buried under several inches of sand, cargo, and other hull structure. The lower outer hull plank joins the chine log 1-1/4 in. in from the chine log's inner edge. Side frames are not pocketed into the chine log, but rather are fastened inboard of the chine log (Figure 22). The chine log tapers at an angle towards the lower outside edge, with no visible evidence of how it fastened to the lower hull. Molded dimension appears to be 6 in. Vessel sheer was difficult to determine due to the break in the hull side, but it appears the vessel carried a slight sheer that became more pronounced nearer the bow. The port side's forward fragment sheer radius measured 3-1/8 in.; the stern side fragment had a sheer radius of 2-3/8 in. There was no evidence of side hull ceiling planking.

Figure 20. The exposed port side with outer hull planks, frames, bulwark stanchions, and deck shelf. Photo by Tamara Thomsen.

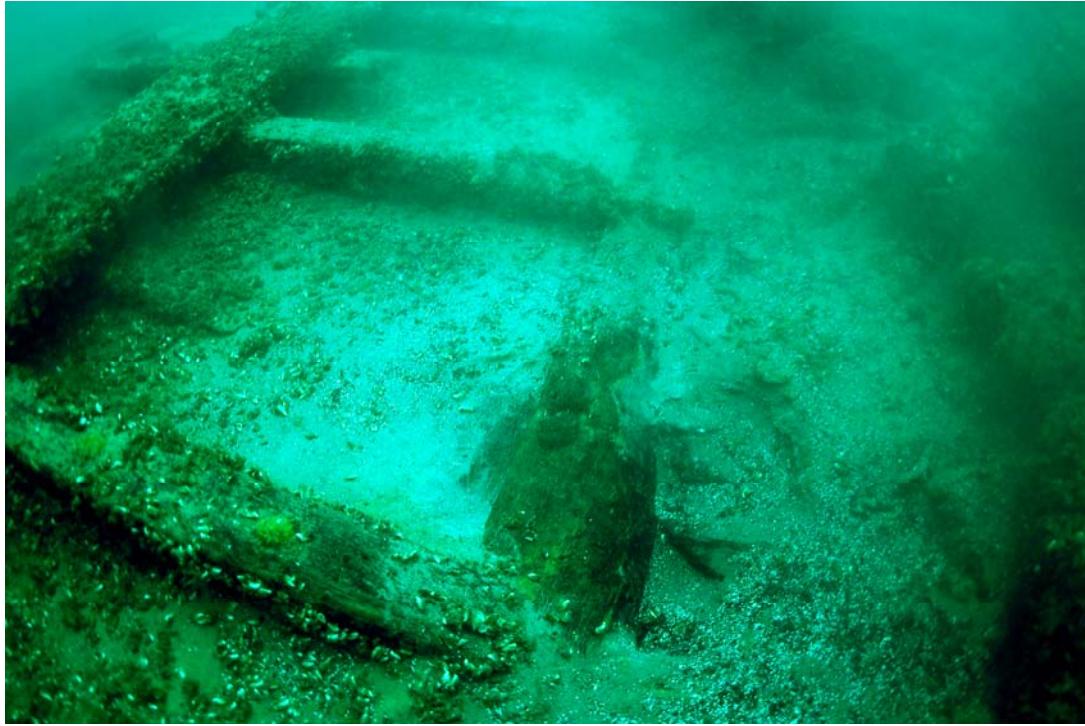
Figure 21. Exposed chine log. Note frames run inside of the chine log. The bulwark stanchion's tapered end is visible between frames beneath deck shelf.
Photo by Tamara Thomsen.

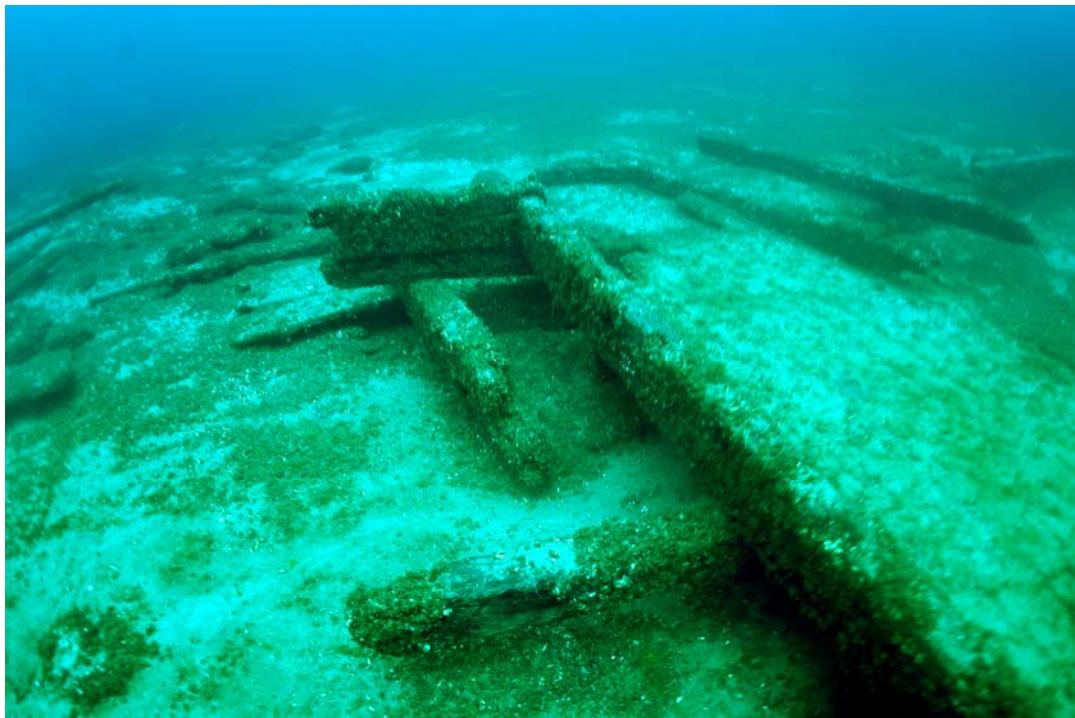
Outboard of the port side hull are two fragments of the forward deck and cargo hatch (Figures 23 and 24). One deck section lays inverted on the bottom, the other upright. The upright section retains one side of the forward hatch combing, which is an unusual 18 ft. 9-3/4 in. long. Hatch width could not be determined as the headledges were broken. The combing measures 9 in. tall by 3 in. wide. Like the aft cargo hatch combing, the forward combing is notched for 9 hatch cover strongbacks. Each of the nine notches are 3 inches long and irregularly spaced from the stern at 2 ft. 2-3/8 in., 1 ft. 4-1/4 in., 2 ft. 4-3/4 in., 1 ft. 4-3/4 in., 2 ft. 4-3/4 in., 1 ft. 4-3/4 in., 2 ft. 5-3/8 in., 1 ft. 4-1/4 in., and 2 ft. 1-1/4 in. Three deck beams cross the hatch's center, irregularly spaced at 2 ft. 10-1/4 in. on center between the forward two beams, and 1 ft. 9-5/8 in. on center between the aft two beams. Deck planking is longitudinal and 1 in. thick. The plank nearest combing is 8 in. wide, with other planks averaging 6 in. wide. Deck planks are fastened 1/4 in. square by 3 in. long rose-head, chisel-point nails. There are two nails per plank at each deck beam at a 45 degree angle to the vessel's centerline. Deck beams on the inverted deck section measure 4-5/8 in. sided by 5-1/4 in. molded, with an irregular spacing of 2 ft. 10-3/4 in., 3 ft., and 3 ft., 2-3/8 in. Two sets of small lodging and bosom knees are present, each knee measuring 13 in. along both the arm and body, and with a gap of 4-1/2 in. between each lodging and bosom knee. Spacing between the two sets is 2 ft 2 in. on center. Deck planking averages 5 in. wide and 1 in. thick.

Figure 23. Forward hatch combing off port side, facing south. Headledge rests atop second, inverted deck section. Photo by Tamara Thomsen.

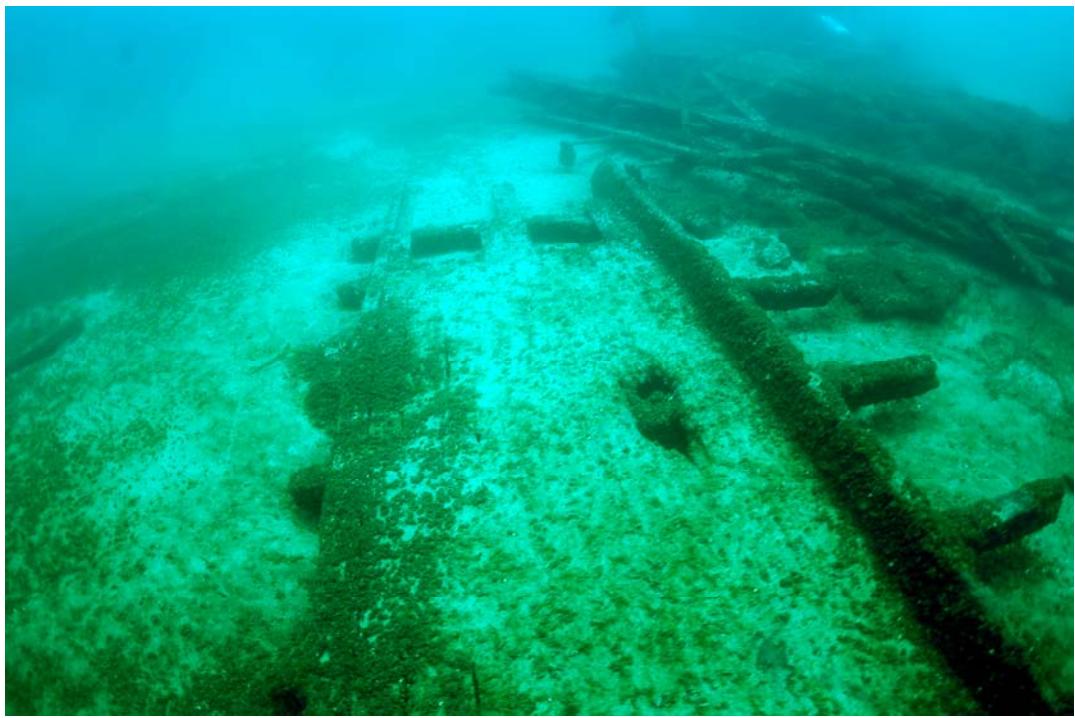
Figure 24. Forward hatch combing and deck, facing north. Note three deck beams protruding beneath combing. Photo by Tamara Thomsen.

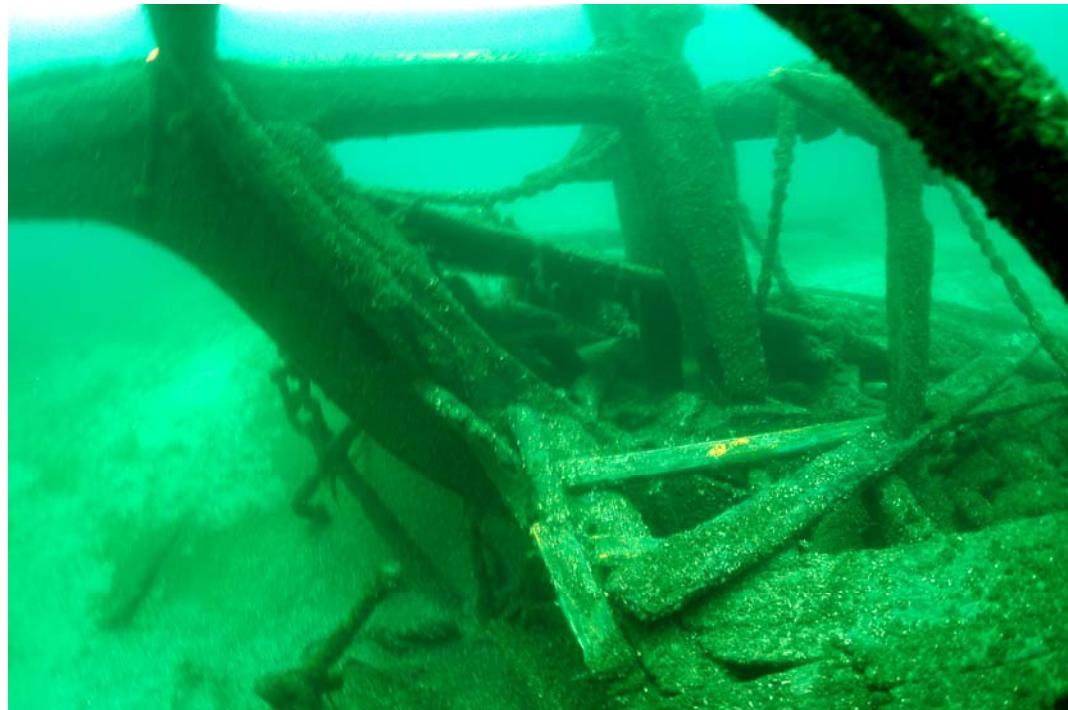
Figure 26. Port side bow. Note gentle curve of stempost and remnant of cross-planking just below knighthead. Photo by Tamara Thomsen.

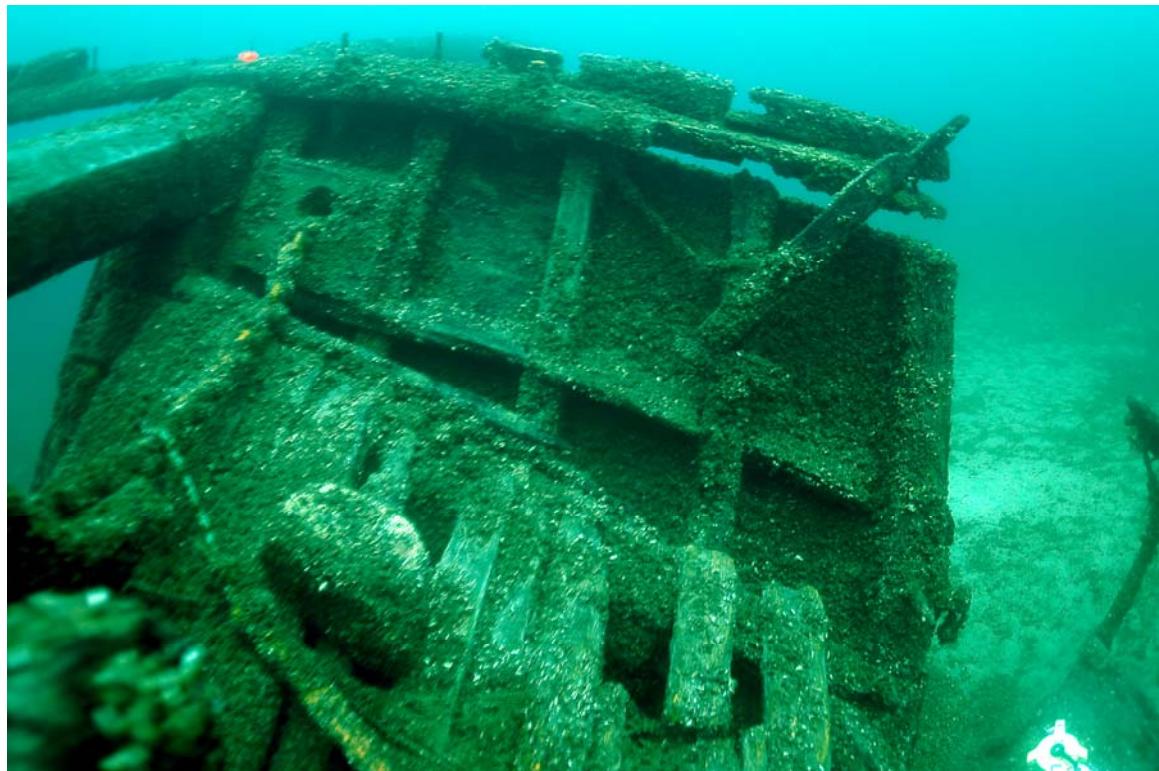
A 7-1/2 in. by 1-1/2 in. breasthook is located 2 ft. 2-3/8 in. below the rail (Figures 27 and 28). The breasthook is parallel with the deck and notched to fit around the frames. Directly beneath the breasthook a deck beam was fastened that measures 8-3/8 in. sided by 7-1/4 in. molded. This beam follows the bow's curvature and rides atop, rather than notched into, the bow frames, and is fastened to the frames with 5/8 in. bolts. Deck planking is attached atop the beam and fits flush with the top of the breasthook (Figure 29). The deck beam, with decking attached, has become dislodged from the bow and lays just below its former location.

Figure 27. Starboard side bow with outer hull planks, frames, breasthook, and dislodged deck beam and planking. Photo by Tamara Thomsen.

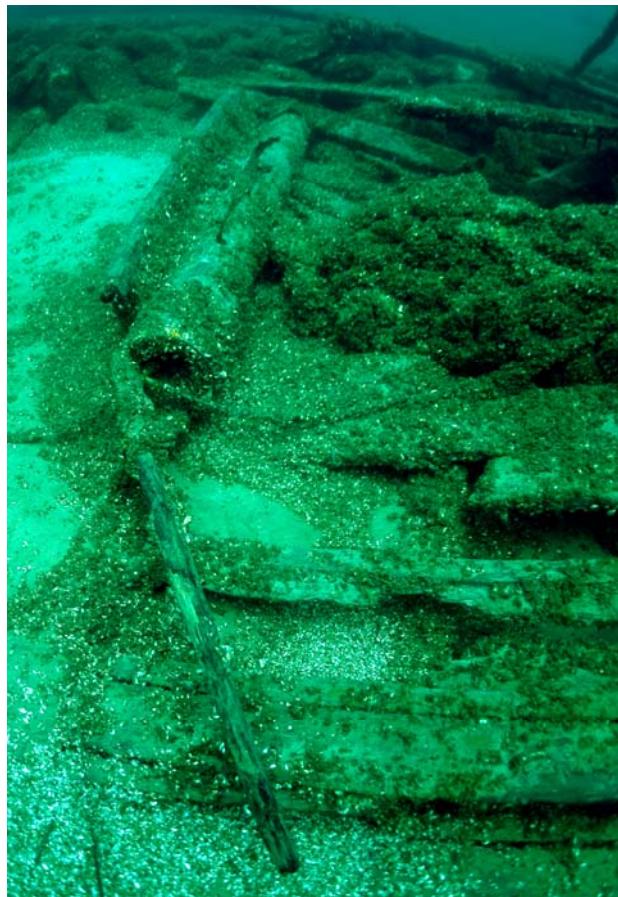
The chain locker is beneath the windlass, and anchor chain spills onto surrounding wreckage. On either side of the chain locker are partial sections of the port and starboard foredeck, dislodged and fallen onto the lower hull and remaining cargo. Foredeck plank widths vary from 6 in. to 9-5/8 in. Plank length varies from 4 ft. to 12 feet. Atop the starboard side foredeck is a small kedge anchor that is missing its stock and one fluke. The shank is 2 ft. 8-3/8 in. long, and the arms measures 2 ft. 3-5/8 in. from bill to bill. The existing fluke measures 8-3/8 in. across its widest part. Aft of the chain locker is a wooden-barreled, single-acting bilge pump (Figure 30). The pump barrel is 6 in. in diameter and 7 ft. 1-1/4 in. long. The pump shaft is beginning to deteriorate, and is approximately 1/2 in. thick. A wooden pump handle, 4 ft. 6 in. long, is fastened to the upper end of the pump barrel.

Figure 30. Bilge pump aft of chain locker. Photo by Tamara Thomsen.

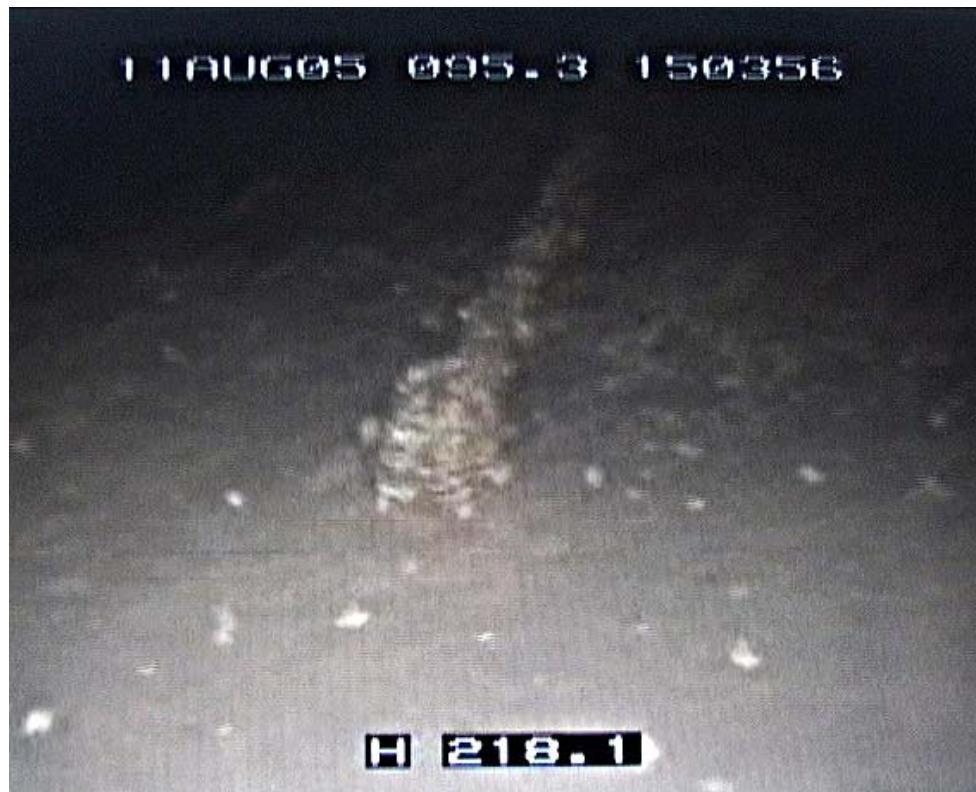
anchor chain or a bobstay. Both the wire rope and chain exhibit varying amounts of corrosion with sporadic quagga mussel colonization. Laying on the lakebed near the chain is an iron-stock anchor (Figure 38). Looking up from the bottom, wire rigging was visible suspended above the lake floor, perhaps hanging from an upright mast. Off the hull's starboard side a shroud lays on the lakebed. Most likely from the starboard foremast, the shroud is draped from the starboard gunwale and extends away from the hull. A sail boom lays on the bottom next to the shroud, jaws intact. Two pieces of white porcelain, one perhaps a teacup, were visible protruding from the silt.

Figure 38. Iron anchor stock on the lakebed off the starboard bow.

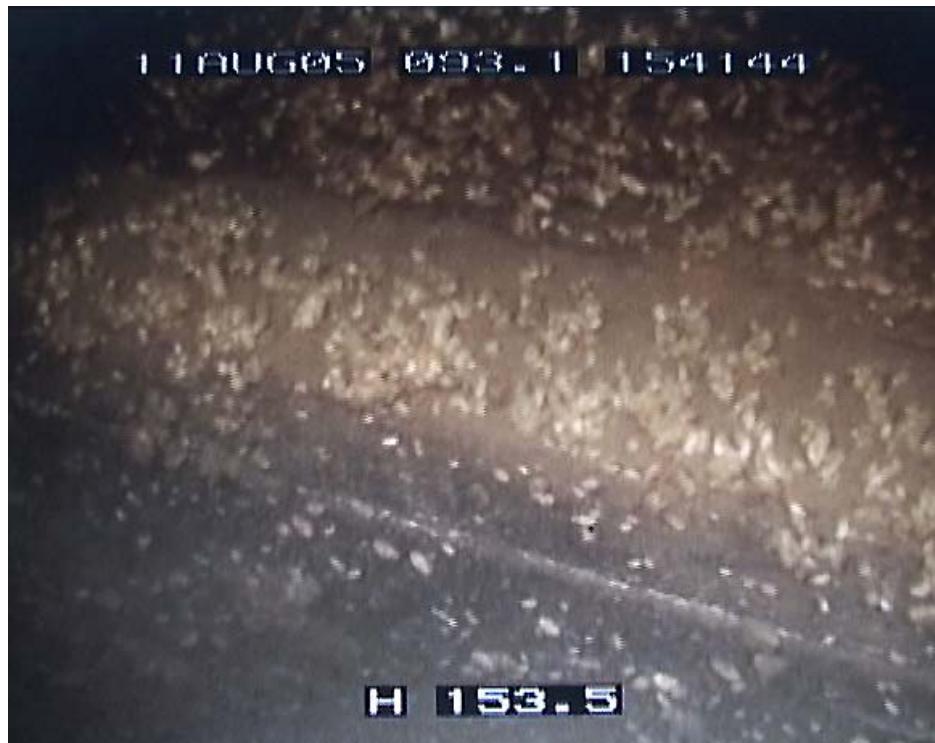
The large amount of rigging off the starboard bow was a serious entanglement hazard for the ROV, and exploration was moved to the port side, where there was little debris outside the hull. The ROV approached the hull approximately amidships, and slowly worked its way forward along the outside of the hull. The hull exhibits construction traits similar to the *Ocean Wave*. Longitudinal side planks had through bolts with clinch rings not unlike the *Ocean Wave*, perhaps for the bulwark stanchions. A heavy covering board was fastened atop the hull planks, and the bulwark was recessed from the outer hull by several inches (Figure 39). Remnants of white paint were still visible.

Figure 39. Hull-deck joint on port side, amidships. Note large covering board atop longitudinal hull planks, recessed bulwark, and quagga mussels colonizing the wreck.

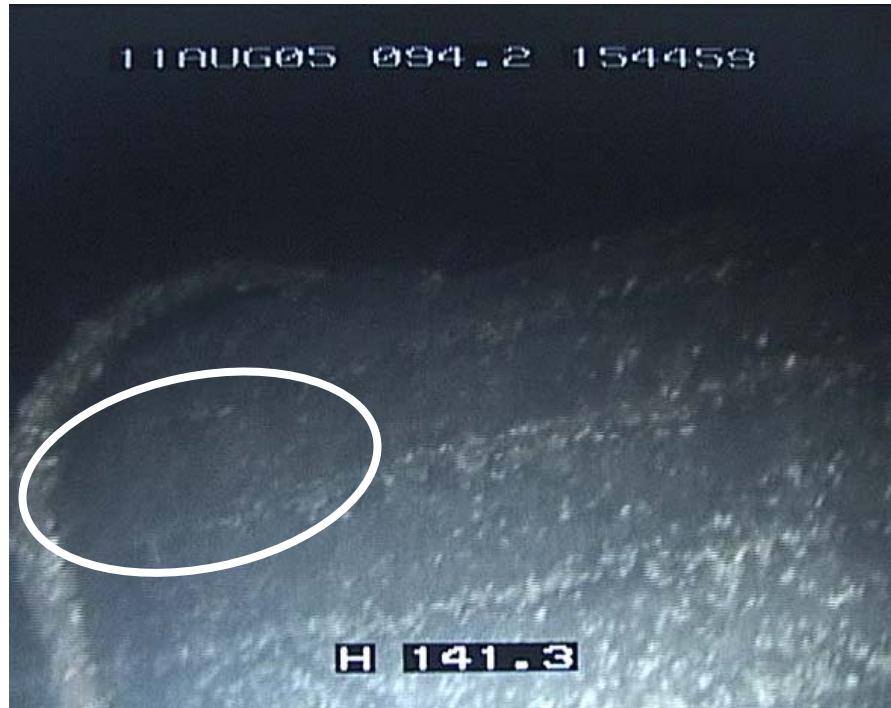
Moving forward, the foremast chainplates were visible, beneath which is at least one dislodged hull plank. Forward of the chainplates a large wire rope is draped over the bulwark, running directly over the port side name board (Figure 40). The name was not legible. The hull is intact from the name board forward, as is the lower port side of the bow ramp. The bow ramp is cross planked, joined to the longitudinal side planking by framing timbers (Figure 41). The bow curves up sharply from the bottom.

Figure 40. Port bow with name board (inside circle). Name is illegible.

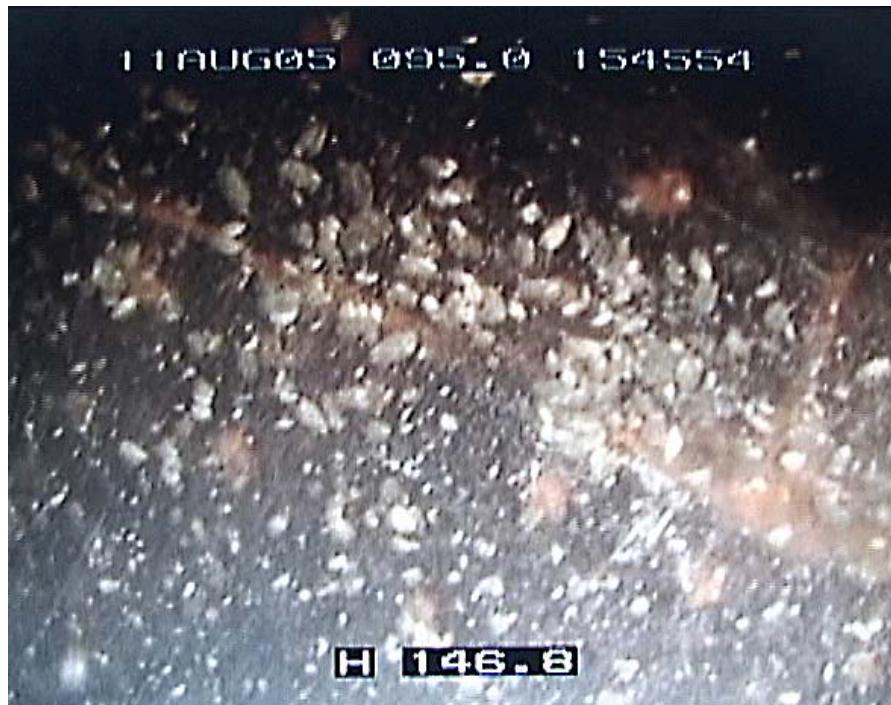
Figure 41. Looking up towards the port side bow ramp. Hull side is in upper right of photo, bow planking in lower left, joined by framing timbers running diagonally from upper left to lower right.

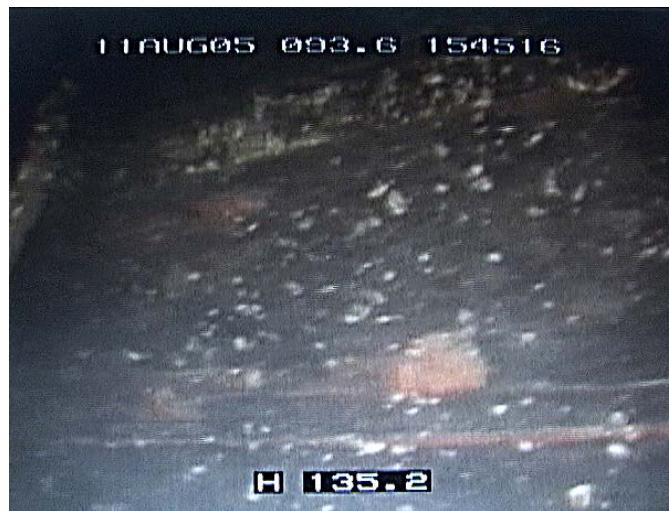
Figure 43. Port side hull from covering board down. Note small rubbing strake just above ROV heading near bottom of photo.
