**Myths and Mysteries:
Underwater Archaeological Investigation of the
Lumber Schooner *Rouse Simmons*, Christmas Tree
Ship**

**State Archaeology and Maritime Preservation Program
Technical Report Series #08-001**

Keith N. Meverden and Tamara L. Thomsen

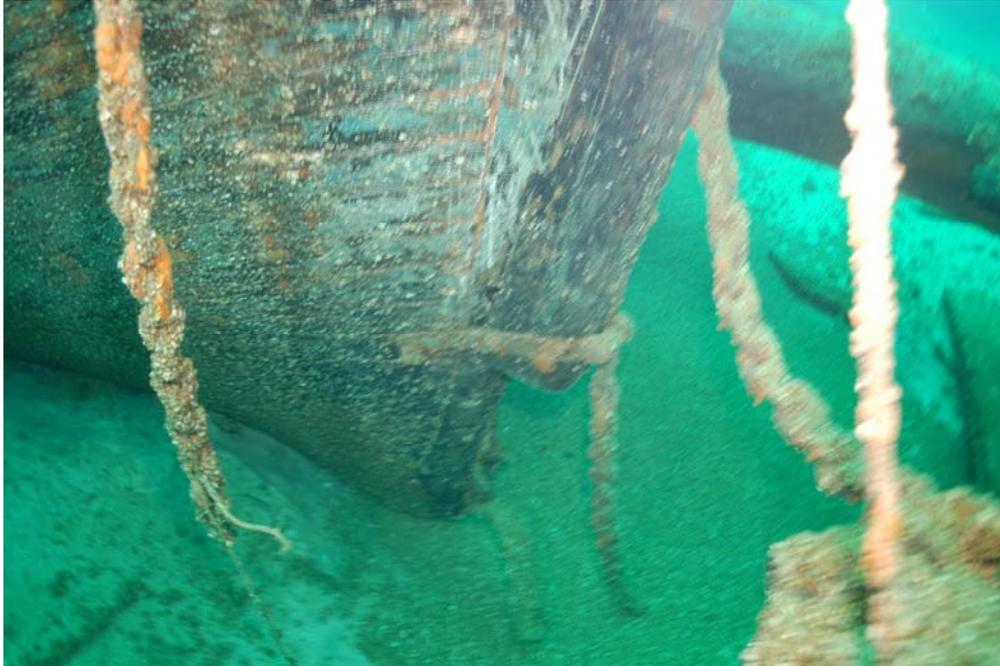
The keelson is inaccessible without excavation, but the keel's extreme forward end is visible from a large depression several feet deep that surrounds the *Rouse Simmons*' bow and leaves the vessel's forefoot unsupported (Figure 7). The forward 2.0 feet of keel is exposed, revealing a sided dimension of .5 feet. The gripe was broken away with the vessel's impact with the bottom and is not extant, but the iron bolts that fastened the gripe to the stem remain. The gripe was 3 feet in length and was butt-scarphed to the false stem, reinforced with an iron strap that wrapped around the face of the gripe and fastened to both the false stem and keel. The reinforcing strap remains attached to the keel, but was pulled free of the false stem when the gripe was carried away and now hangs downward from the keel. The false stem is .9 feet molded and .5 feet sided, and continues upward from the gripe to the stem head, which was carried away with the bowsprit. The stem is intact behind the false stem and is 10.7 feet in

Figure 7. Bow with missing gripe. Iron reinforcing band, encrusted with mussels, is visible hanging below the bobstay plate. Large patches of blue and green hull paint are visible on the stem and outer hull planks.

The bowsprit carried chain inner and outer bobstays. The inner bobstay plate is extant above the missing forefoot with the bobstay chain still attached (Figure 7). The outer bobstay plate was carried away with the forefoot and only its fasteners remain. The martingale backstays were also chain, and according to historic images, attached to the outer hull just below and forward of either cathead with a double sheave block. Neither martingale backstay is extant, but the starboard double sheave block remains stropped to an iron eye fastened to the hull. On the port side only the iron eye is extant.

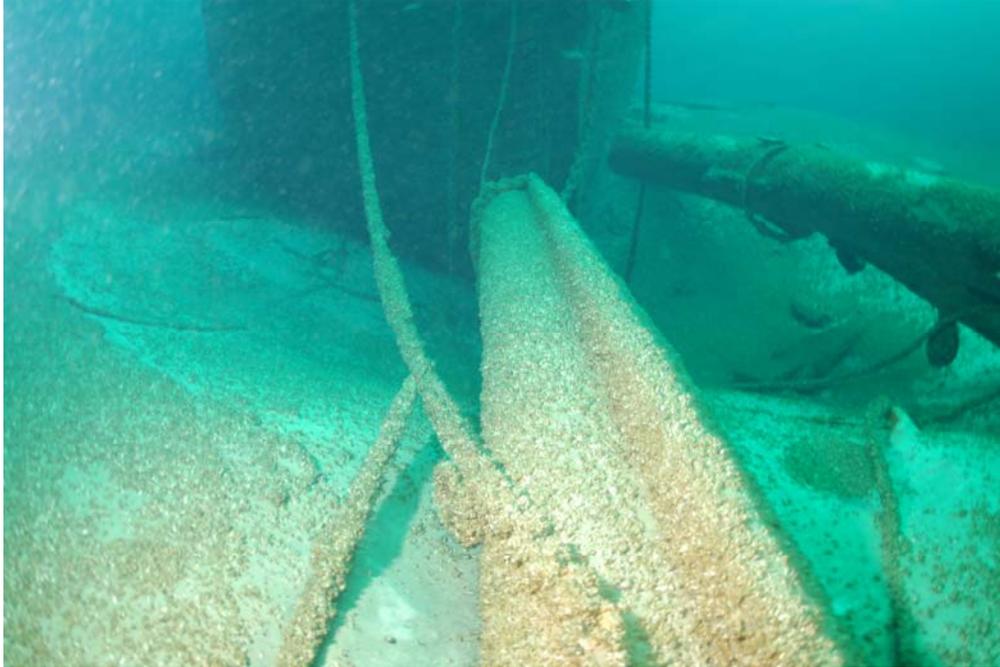
The bowsprit severed at the top of the stem and the hounding (from the stem forward) now lies on the lakebed forward of the hull (Figure 8). The hounding is 18.2 feet long and fitted with an iron cap, but the martingale is not extant. The jib boom remains attached to the top of the hounding and is 48 feet in length. The jib boom's heel is cut into a tenon and is fitted into a mortised block fastened to the top of the hounding. The bowsprit's housing (the section between the samson post and the stem) remains fitted beneath the forecastle deck, mortised into the samson post and penetrating the hull between the stem and rail. The housing is 7.0 feet in length from the samson post to the inside of the stem and measures 1.2 feet square.

Figure 8. The bowsprit hounding and jib boom lies on the lakebed at the *Rouse Simmons*' bow. A chain bowsprit guy remains attached to the starboard bow. The eye for the inner bobstay is visible beneath the bowsprit guy. Note the large depression in the lakebed around the bow.

The port and starboard bowsprit guys were also chain and fastened to iron eyes on either side of the bow immediately below and slightly aft of the martingale backstays. Unlike the martingale backstays, the bowsprit guys were fastened directly to an iron eye without a block. Both the port and starboard side bowsprit guys are extant. The port guy is attached to the hull only, and hangs down into the lakebed. The starboard guy is intact and remains attached to both the hull and the bowsprit (Figure 8).

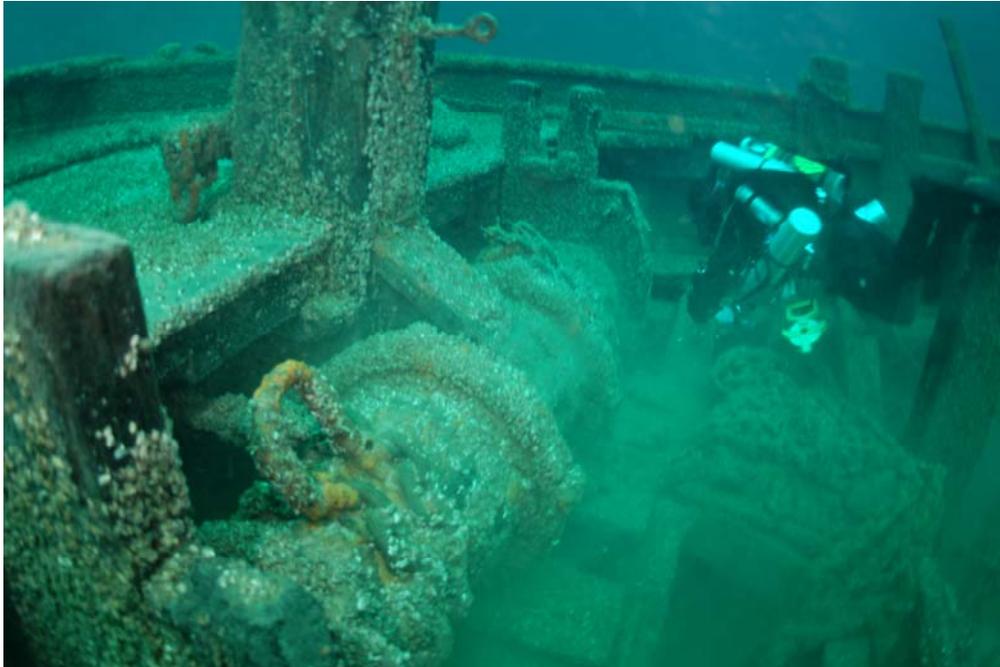
Figure 11. View of the windlass from the port side. Note starboard anchor chain piled on deck below diver.

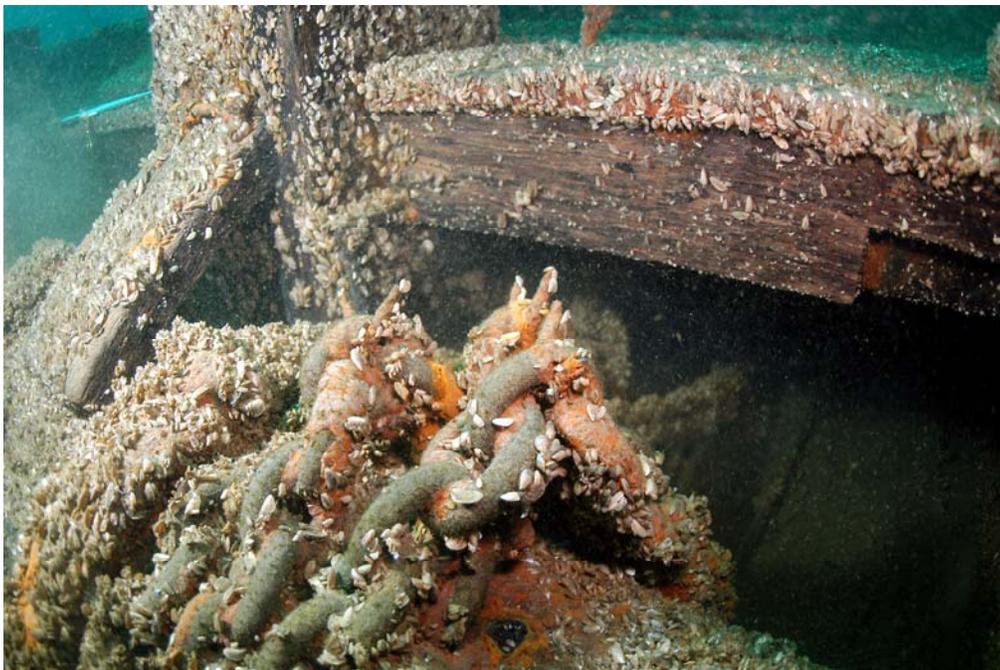
Examination of the windlass revealed that the crew was preparing to set the port anchor prior to the vessel sinking. The turns of the anchor chain around the starboard side of the windlass have been loosened and tied to allow the windlass to revolve without working the starboard anchor chain (Figure 12). The strongback to which the chain was tied is no longer extant, but the anchor chain has rusted into place and portions of the natural fiber line that tied the chain to the strongback remain attached to the anchor chain. The gap between the raised links and the windlass drum is large enough to allow a diver to pass his hand between them.

Figure 12. Starboard side of windlass with turns of the anchor chain loosened and tied to allow the windlass to revolve without working the starboard anchor chain. Note the remnants of line protruding from the upper chain links.

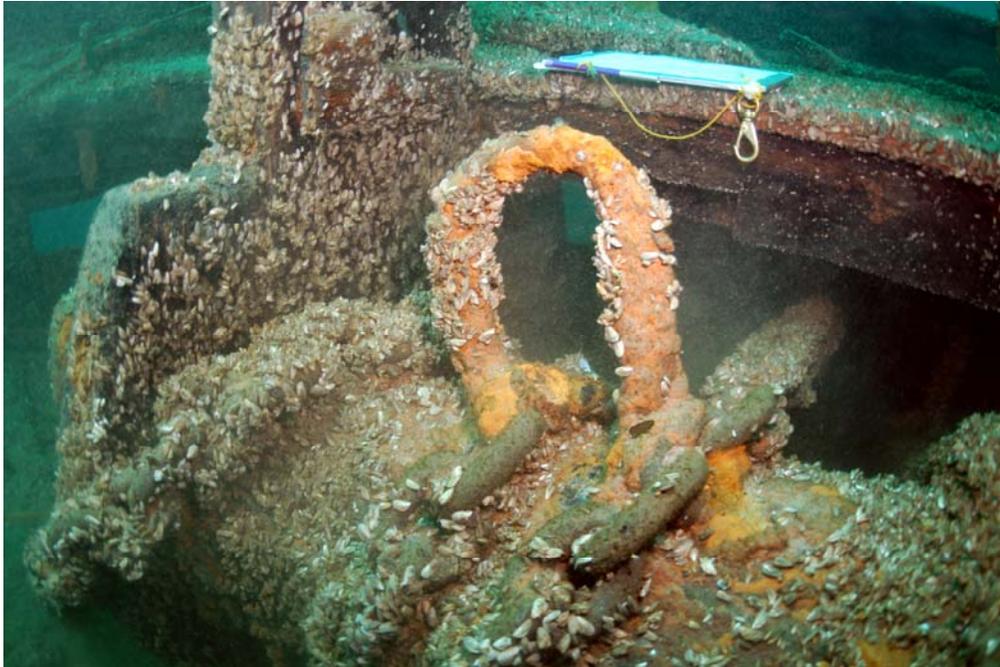
Figure 13. Port side of windlass with norman pin. Note notch in forecastle deck beam. An identical notch is also cut into the beam on the starboard side (see Figure 12).

The windlass' port side has a norman pin, or a large iron staple, embedded in the windlass around the middle turn of the anchor chain (Figure 13). The norman pin, an early form of chain stopper, was driven into the windlass once the anchor was set to lock down the chain and prevent it from running out under strain (Wilson 1928). The aftmost beam of the forecastle deck is notched; apparently to allow for clearance of the norman pin should the windlass revolve with the norman pin in place.

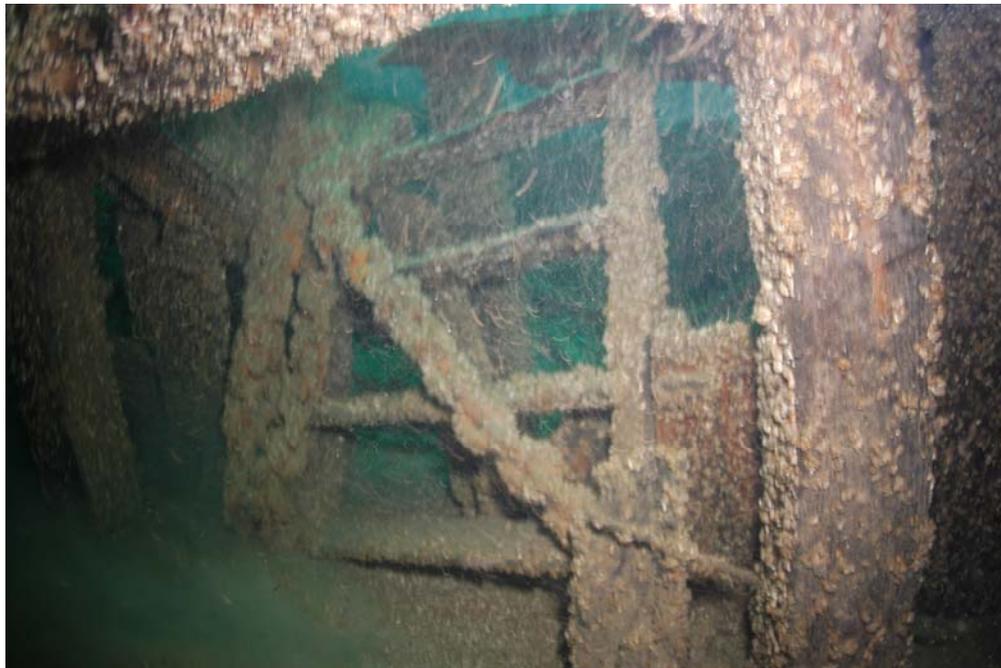
Figure 14. Forecastle ladder, looking aft from the forecastle. Some of the starboard anchor chain spills down the scuttle. The vertical timber on the right is the deck pipe leading to the chain locker.

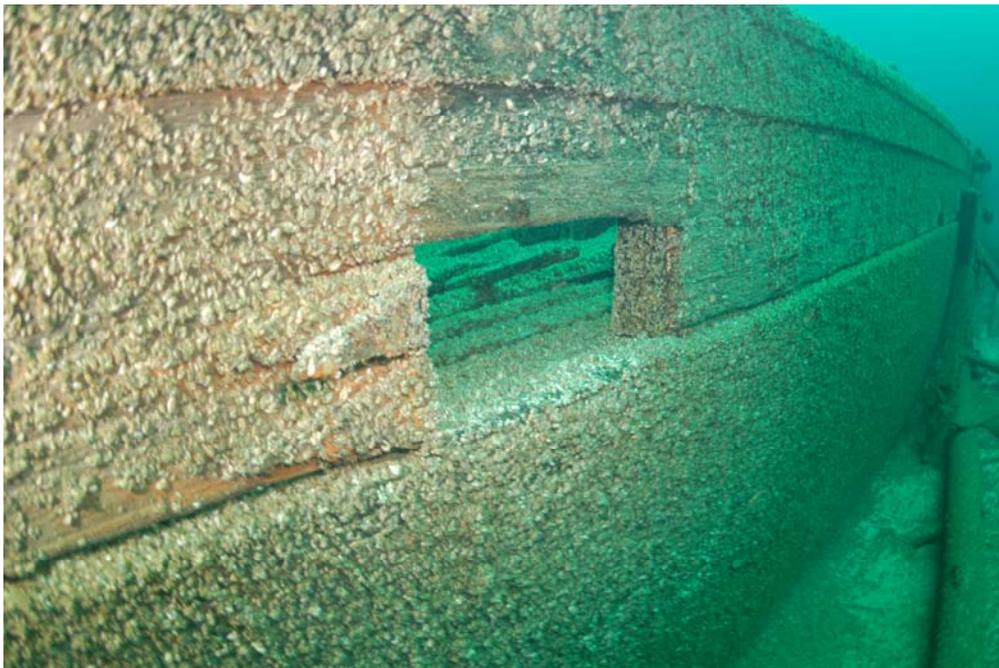
Three sets of lumber ports are located in both the port and starboard bulwarks (Figure 17). The port dimensions are 2.9 feet long by 1.0 foot high, and are located on either side of the vessel at distances of 41.5 feet, 57.7 feet, and 79.7 feet from the stem, measured along the vessel's centerline at each port's forward edge. The port covers are not extant, but were fastened with two triangular hinges that opened outboard and toward the bow. Each hinge is 1.1 feet in length from hinge to tip, with one fastened above the other.

Figure 17. Forwardmost lumber port on the port side with two extant hinges. The freeing port is visible along the bottom of the bulwark, as well as the two thicknesses of bulwark planks.

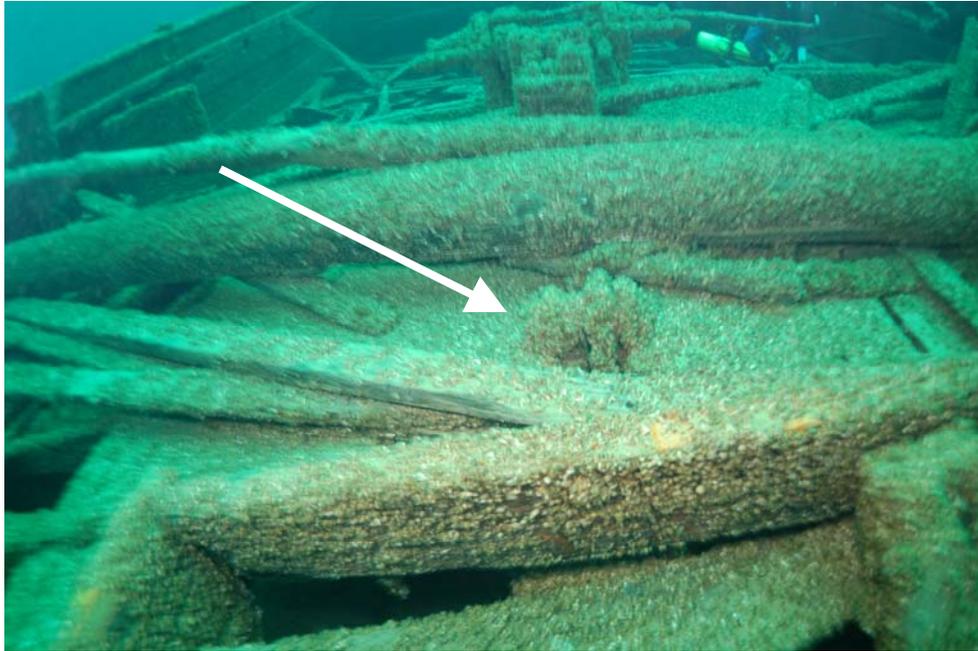
A broken boom lies in two pieces on the aft deck. The boom's aft section lays athwartship between the aft centerboard pulley and centerboard winch (Figure 18) and has a diameter of 1.0 foot at the break and .95 feet at the end. The fragment is 21.5 feet in length with a double sheave sheet block attached to an iron band and bale 6.9 feet from the end. The boom's forward section lies farther forward on the port side of the center cargo hatch. The forward section is 9.0 feet long from the break to where the jaws begin. Total length could not be measured as the forward end lies below the deck amidst a large pile of debris. Its diameter is 1.0 foot at the break.

Figure 18. Pulley for aft centerboard chain (denoted by arrow). Note distance to centerboard winch farther aft on deck. Aft cargo hatch is visible at bottom of photo.

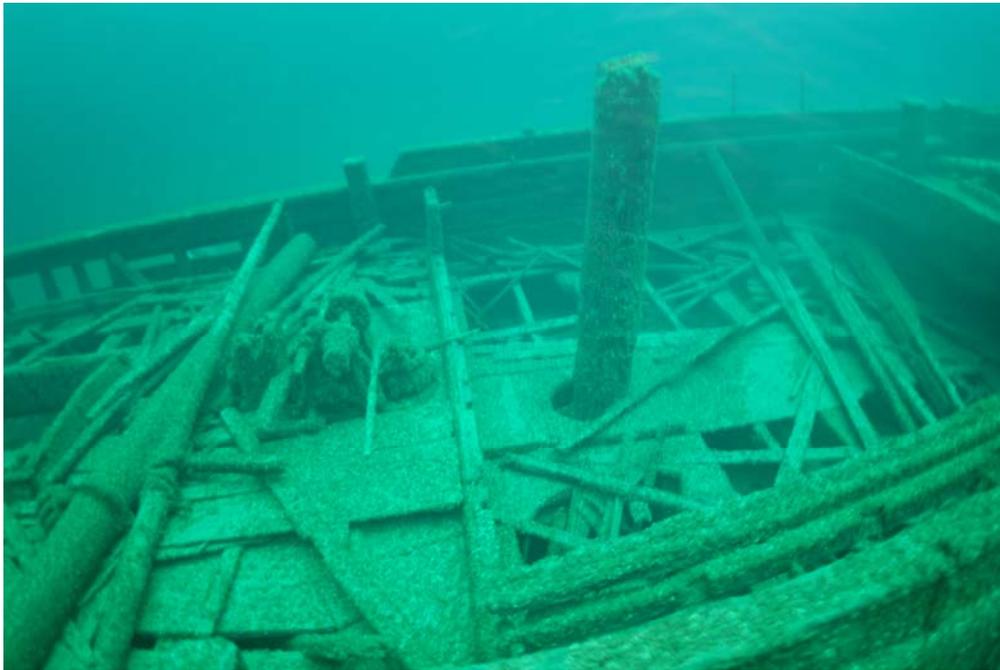
The stern cabin is missing, but its former location is discernable between the bilge pump and the after deck (Figure 19). The cabin's dimensions are 15.7 feet long by 18.5 feet wide, and it is offset to the starboard side. The cabin's starboard bulkhead abutted the starboard rail, allowing a 2.8 feet wide passageway between the cabin's port bulkhead and the port rail. The cabin's forward bulkhead separated the weather deck and after deck levels; the after deck is 1.9 feet higher than the weather deck. The cabin floor is 1.5 feet below the weather deck. The cabin's forward head ledge is scored at irregularly spaced intervals to receive strongbacks or frames that are no longer extant. The scores are .3 feet wide, .2 feet deep, and .2 feet tall. The cabin floor's planking averages .5 feet in width, but varies between .4 feet .55 feet. The cabin's floor is supported by athwartship beams that are .7 feet molded and vary in sided dimensions between .3 feet and .9 feet. There is a berth of 1.9 feet between each beam. The cabin's forward bulkhead is located 105.3 feet from the bow and the cabin's aft bulkhead is 121.0 feet from the bow. The ship's stove was located at the cabin's forward port corner, but has fallen through the floor and now lies in the lower hold under a heavy encrustation of zebra mussels (Figure 20). The stove is 2.0 feet wide and 2.6 feet long. The cabin's entrance was 2.0 feet wide and was located at the port quarter. A head ledge .8 feet in height kept water from entering the cabin through the companionway. To starboard of the companionway, the head ledge rises to 1.2 feet above the after deck. The mizzenmast penetrated the cabin roof, and is located 2.8 feet from the cabin's forward bulkhead. A through-hull fitting penetrates the hull beneath the cabin's starboard quarter, most likely for a water closet (Figure 18). The through-hull pipe is .4 feet in diameter and is located 7.8 feet forward of the transom and 9.5 feet from the starboard rail.

Figure 19. The cabin's former location is visible near the stern. The mizzenmast broke above the cabin roof, and the base of the mast remains in the hull. The bilge pump, centerboard winch, and boom are visible forward of the cabin.

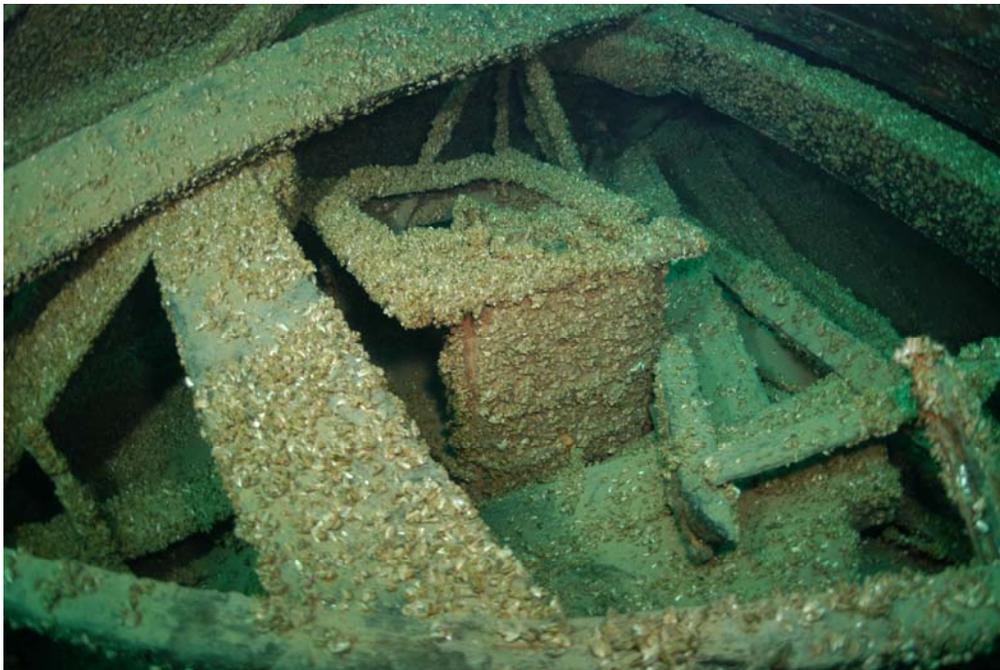
Figure 20. The stove has fallen through the cabin floor at the cabin's forward port corner.

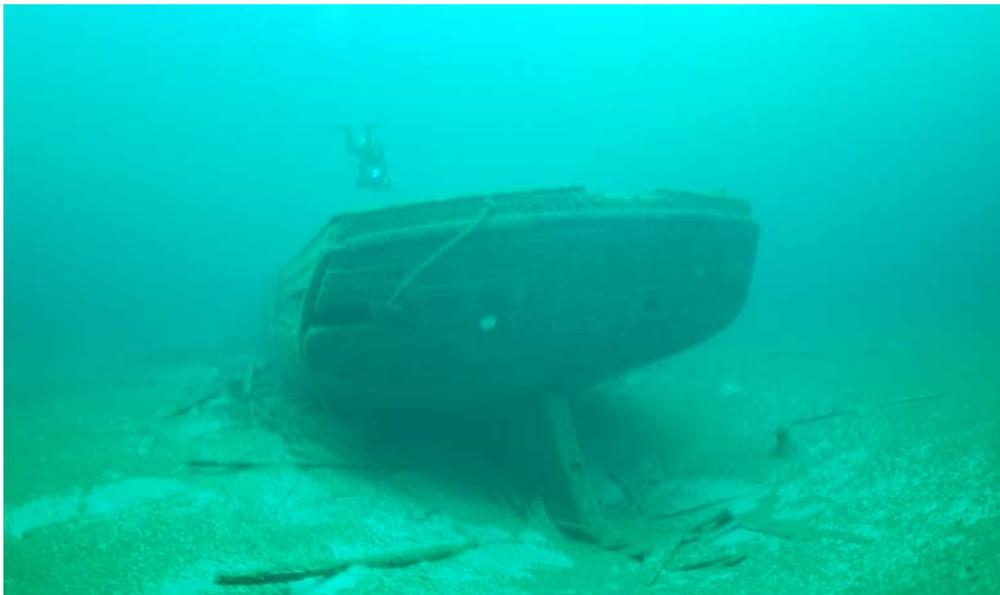
At amidships the transom is 7.8 feet tall, and is partially dislodged on the port side (Figure 23). The transom is planked with 13 horizontal planks that are each .35 feet wide, with the exception of the three lowest planks, which are .8 feet wide. Two circular dead lights penetrated the transom to provide light for the lazarette and pantry. Both deadlights have been removed by divers, and the remaining openings are both .75 feet in diameter. They are located 3.0 feet above the bottom of the transom and 6.6 feet from either quarter.

Figure 23. The transom is intact, but dislodged at the port quarter.

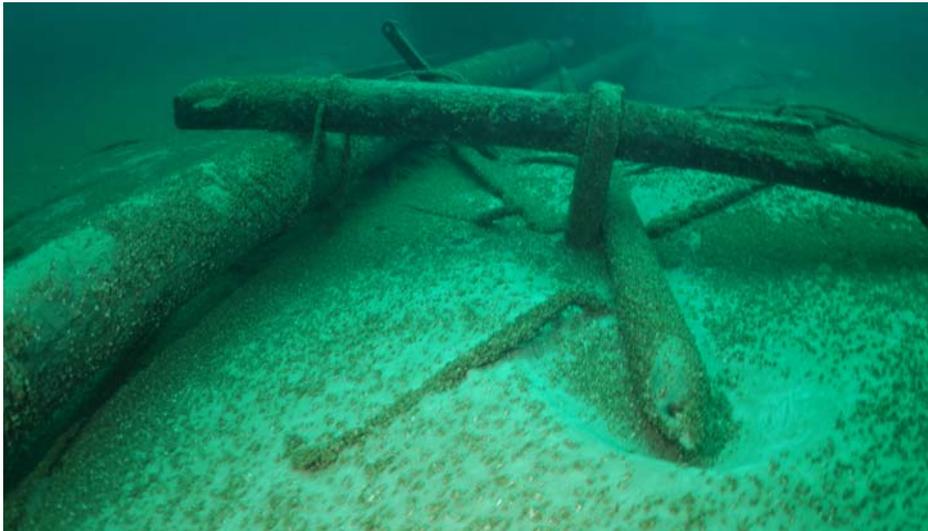
An unidentified wooden spar lies beneath the main topmast, nearly parallel to the lower masts (Figure 28). This spar's identity has not been confirmed, but may be the fore staysail boom. One of the spar's ends is tapered with a hole bored through the end at the base of the taper. This spar is broken near the vessel's bow, but its extant length is 31.8 feet with a .5 foot diameter at the break and a .35 foot diameter at the tapered end.

Figure 28. Unidentified spar lies beneath the main topmast, possibly the fore staysail boom.

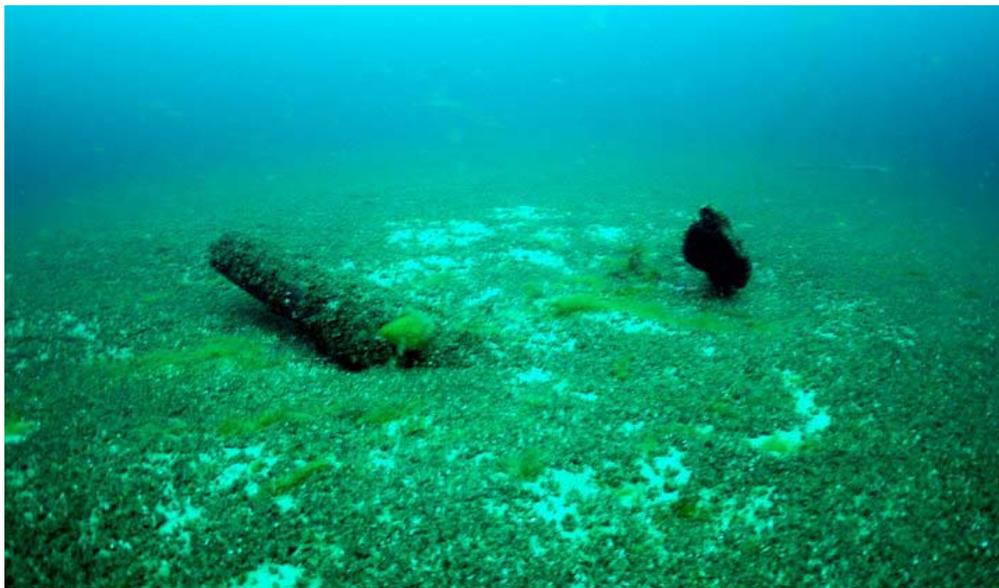
On 21 July 2007 Keith Meverden and Tamara Thomsen returned to the *Rouse Simmons* to search for the port anchor. Within minutes, the anchor was located 170 feet due north of the vessel's stem (Figure 32). The shank was oriented toward the *Rouse Simmons* with the eye nearest the hull, and an estimated 188 feet of chain between the hawse pipe and the anchor. It was unlikely the anchor had simply fallen overboard as the *Rouse Simmons* capsized. In order to have fallen overboard it would have had to have been unlashed from the bitts, something that wouldn't have happened in the open water during a gale - a large anchor loose on deck in a heavy sea would have been hazardous to both the crew and the vessel. It's also unlikely it broke free during the wrecking event since the starboard anchor remained lashed. The port anchor is set into the bottom and was obviously holding the bow into the wind. If it had simply fallen overboard as the vessel sank it would not have been dragged along the bottom nor set so deeply into the bottom, and the *Rouse Simmons*' hull would not be on a northwest heading. The crew had deliberately deployed the port anchor before the *Rouse Simmons* sank.

Figure 32. The port anchor as it was discovered 21 July 2007.
