Wisconsin's Cross-Planked Mosquito Fleet:
Underwater Archaeological Investigations
of the Scow Schooners
Iris, Ocean Wave, and Tennie and Laura

State Archaeology and Maritime Preservation Program
Technical Report Series #06-001

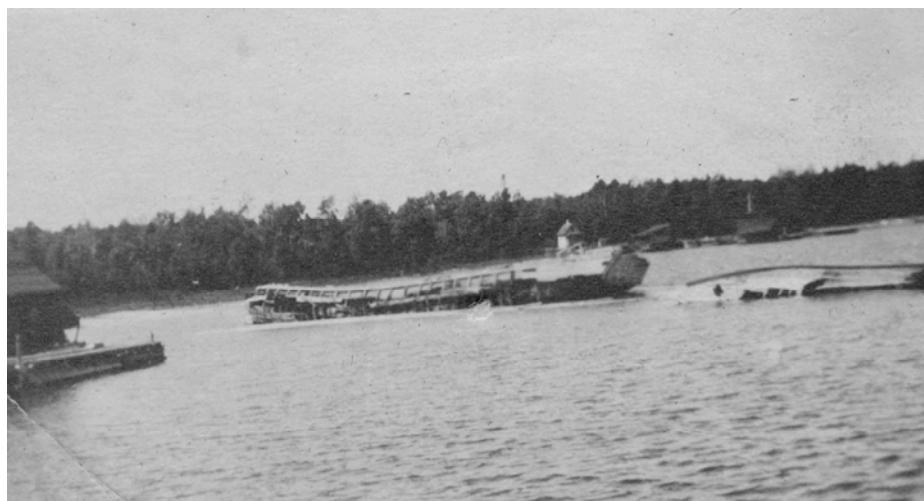
Figure 4. Photograph of *Iris* abandoned at Jackson Harbor, date unknown. Wreckage of gas boat *Sadie* is visible off the *Iris*' stern. Courtesy Wisconsin Maritime Museum.

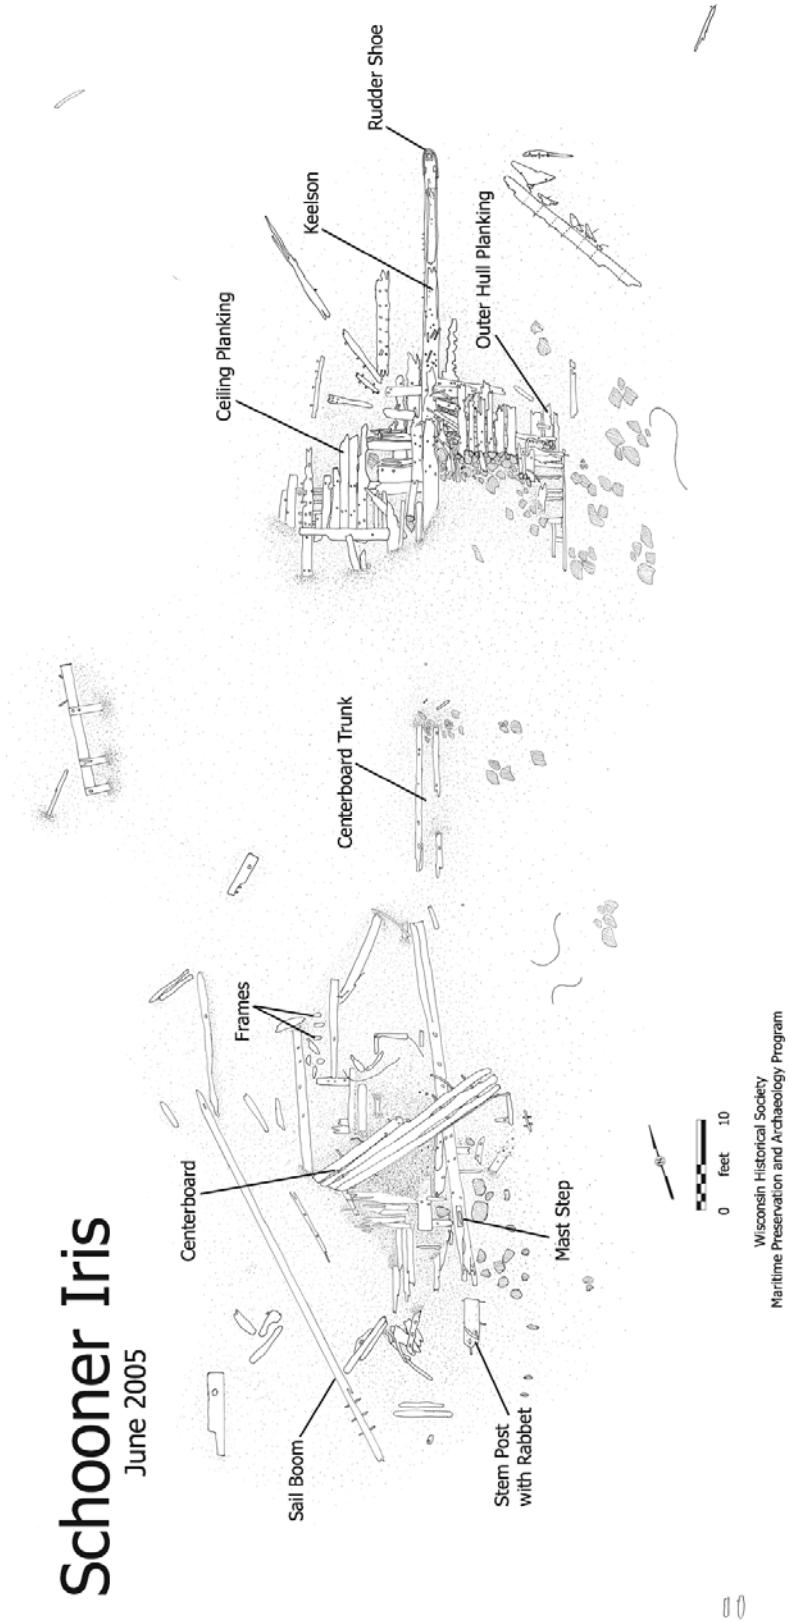
Figure 7. *Iris* site plan.

The *Iris'* remains are quite weathered, having been subjected to 47 years of Great Lake service, followed by 92 years of storms, ice, sun, and salvage. Only the hull's lower bilge remains intact. No evidence of the vessel's sides or deck was discovered. Much of the vessel lays beneath dredge spoil from an adjacent slip that conceals much of the lower hull with the exception of a portion of the centerboard and centerboard trunk, a 23 foot section of the forward hull from the sternpost aft, and a 25 foot section of the after hull from the rudder shoe forward.

Visible construction details are those of a small sailing vessel with a keel length of 72 feet from the center of the rudder shoe to the forward edge of the keelson, comparable with the *Iris'* registered length of 72 feet. Beam was difficult to determine due to heavy overburden. The widest visible breadth was 24 feet forward of the rudder shoe where the port side frames, broken just below the turn of the bilge, extend 8 ft. 3-5/8 in. from the center of the keelson. Starboard side frames at this location were broken much closer to the keelson than on the port side. Compared with historic photographs and the relative position of the centerboard trunk, this location was just aft of the mainmast, and likely not the widest part of the hull. Doubling the port side measurement gives an estimated beam of 16 ft. 7 in., within the *Iris'* registered beam of 19.2 ft. Depth of hold could not be determined.

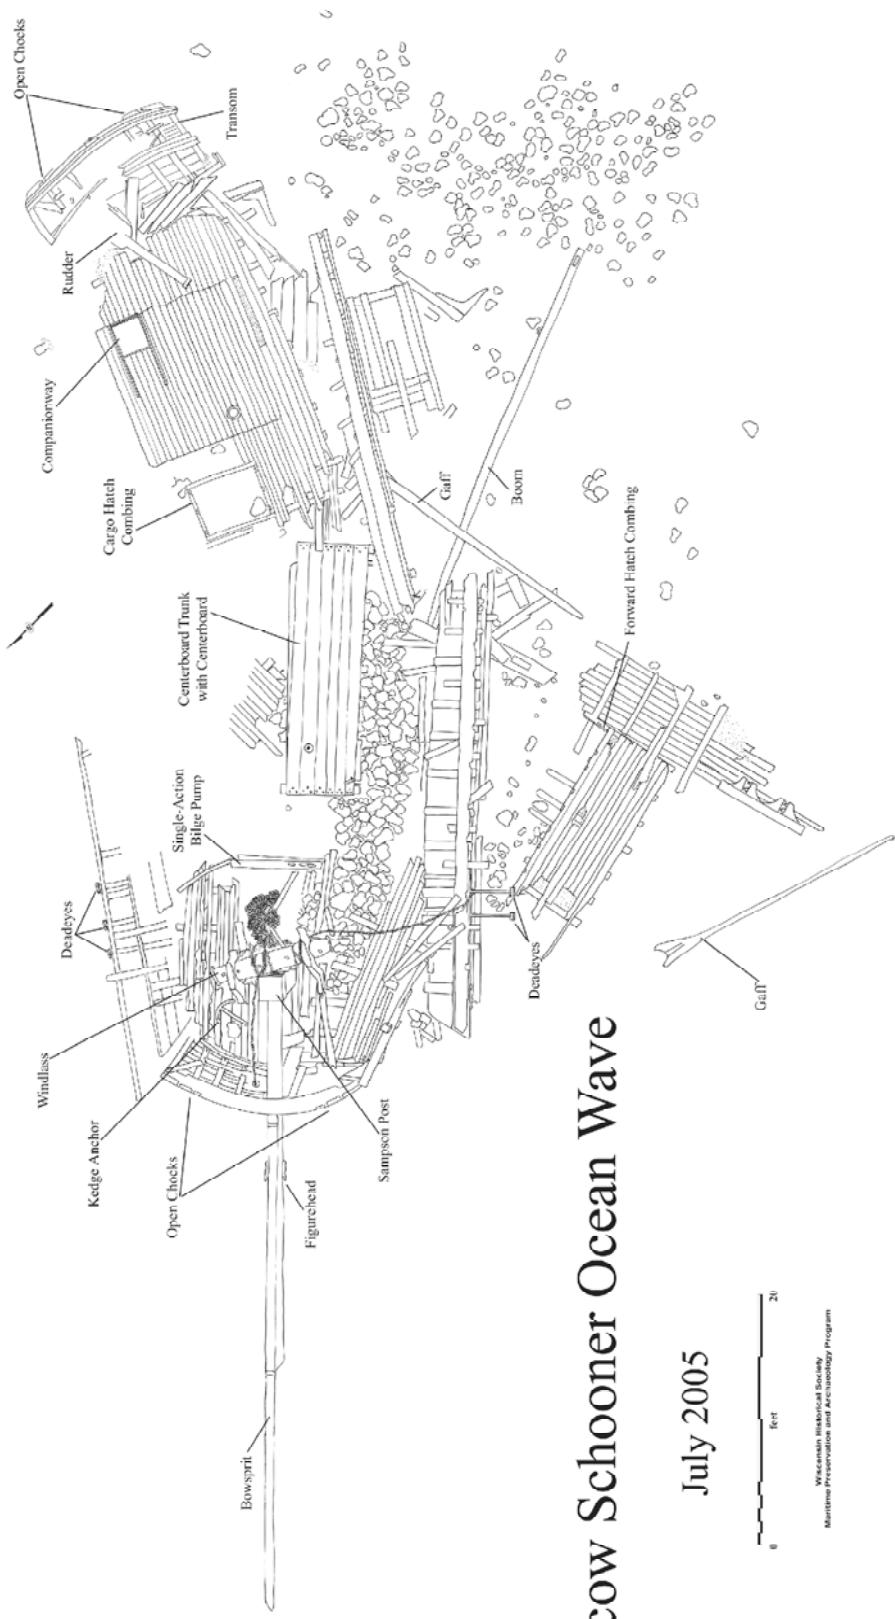
The *Ocean Wave* capsized near the surface, breaking away the foredeck and spilling cargo onto the lakebed. On her descent she righted herself and drifted slightly northeast, striking the bottom stern first with the bow settling more gently afterward. The collision with the bottom broke her keel and port side hull and dislodged the starboard side. The transom separated and fell astern and the cabin and rear deck collapsed onto the bilge. Subsequent to striking the bottom, the wreck has been encountered one or more times by commercial fishing nets, which may have contributed to her hull collapse. Structures with both significant relief and laying flat on the bottom are entangled in net. A dense tangle of net is snagged off the cabin's port side. This tangle is approximately one foot in diameter and rises six feet from the bottom, suspended by aluminum floats. Most of the netting is woven cotton. This suggests that with the exception of the 2003 encounter that led to the wreck's discovery, it had been many years since the *Ocean Wave* was snagged with commercial fishing nets.

Figure 17. *Ocean Wave* site plan.

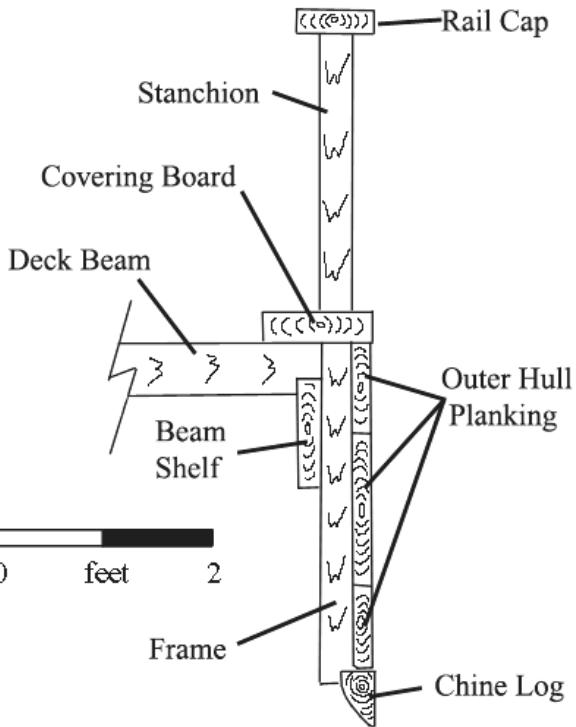
Figure 22. Hull side cross section.

The hull sides are supported by both frames and bulwark stanchions. Frames begin at the chine log and extend 3 ft. vertically to the underside of the covering board (Figure 22). The frames are 4-3/4 in. square and vary in spacing from 2 ft. 10-3/4 in. to 3 ft. 3-5/8 in. No pattern was detected in the variable frame spacing, which appears to be random. Between each frame set is a bulwark stanchion that passes through a mortise in the covering board. The covering board is extant aft of the break on the port side hull, but all bulwark stanchions are broken just beneath the covering board along the entire port side. Several bulwark stanchions are extant on the starboard side near the foremast chainplates, extending 2 ft. 3-5/8 in. above the covering board and 2 ft. below. The stanchions taper near the bottom and are fastened to the hull sides with two through bolts with clinch rings spaced 9-5/8 in. on center. Atop both the frames and bulwark stanchions is a deck shelf 1 ft. wide by 2-3/8 in. thick. The deck shelf has irregularly spaced notches for the deck beams that measure 2-3/8 in. deep and 4-3/4 inches wide. The irregular spacing is similar to that found in the deck beams that remain attached to the aft deck section. Two foremast chainplates remain intact on the portside hull, 1/2 in. thick and 2 in. wide, 1/2 in. narrower than the starboard foremast chainplates.

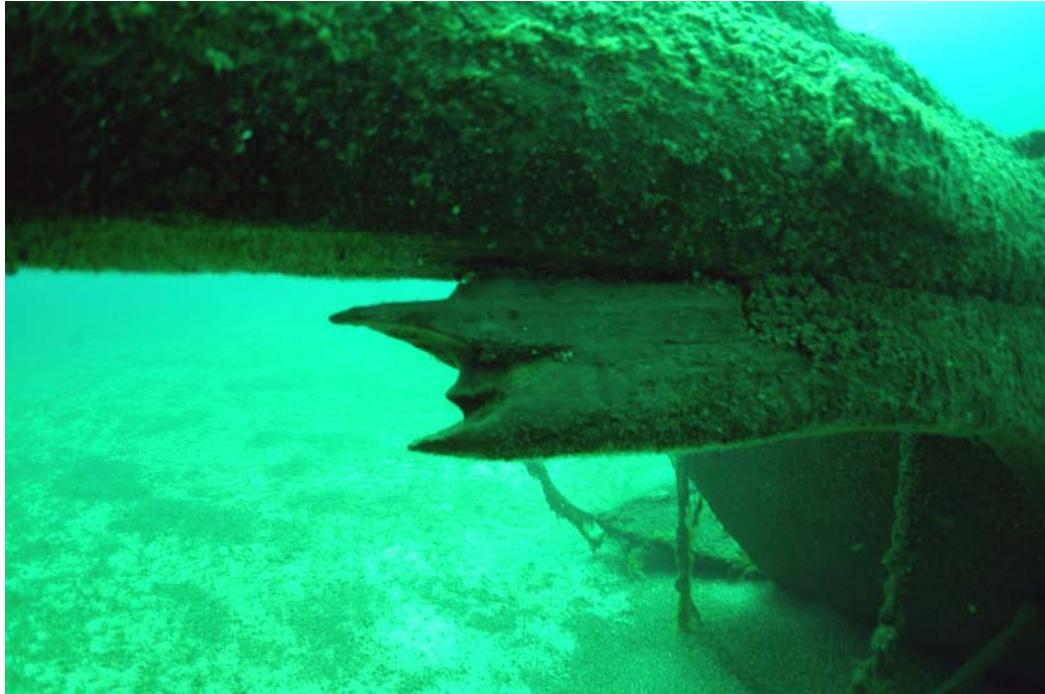
keel to the bowsprit, ending in a crude eagle figurehead with an open mouth and extended tongue. Traces of red paint are visible on the eye and tongue (Figure 25). The starboard bow remains wholly intact, but the port side has collapsed with the exception of the bow and port side rail caps. The stempost is constructed from one large timber, measuring 1 ft. 4-1/4 in. sided by 2 ft. molded at the waterline. On either side of the stempost is a knighthead measuring 7-1/4 in. sided by 4-3/4 in. molded (Figure 26). The knighthead begins at the underside of the rail cap and extends downward for 5 ft. 8-3/8 in. The stempost is not rabbeted for the outer hull planking. Below the knighthead's terminus there is no visible support where the planking abuts the stempost. The bow is cross planked, and the cross planking continues down the bow, curving towards the horizontal where it disappears into the lake bottom. There is no evidence of a hard chine-type edge between the bow and hull bottom. The bow curves towards the horizontal to become the vessel's bottom with no visible transition.

Figure 25. Eagle figurehead. Photo by Tamara Thomsen.

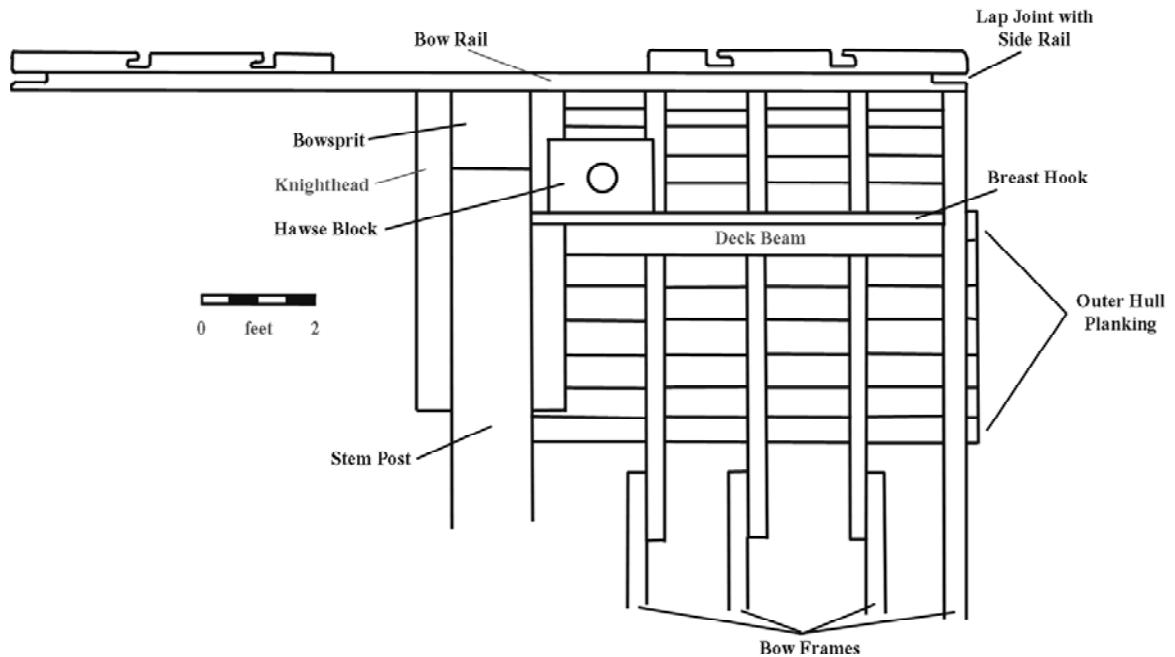
The bow's upper edge is covered by a one-piece head rail that is 10-3/4 in. wide 3-1/2 in. thick, and curves aft from the stempost with a radius of 1 ft. 8-3/8 in. (Figure 28). The bow is 16 ft. 9-5/8 in. wide at its widest point, and the ends of the head rail are notched to form a lap joint with the side hull's rail cap, the side rail resting atop the head rail (Figure 29). This lap joint is reinforced by a small horizontal knee that measures 1 ft. 8-3/8 in. along the head rail and 1 ft. 6 in. along the side rail. Atop this lap-joint, sandwiching the side rail, is a double open chock on either end of the bow rail. The chock block is 5 ft. 3-5/8 in. long with two 2-3/8 in. openings, the outermost opening is 2 ft. 1-1/4 in. inboard from the side, the next is 2 ft. inboard of that.

A 7-1/2 in. by 1-1/2 in. breasthook is located 2 ft. 2-3/8 in. below the rail (Figures 27 and 28). The breasthook is parallel with the deck and notched to fit around the frames. Directly beneath the breasthook a deck beam was fastened that measures 8-3/8 in. sided by 7-1/4 in. molded. This beam follows the bow's curvature and rides atop, rather than notched into, the bow frames, and is fastened to the frames with 5/8 in. bolts. Deck planking is attached atop the beam and fits flush with the top of the breasthook (Figure 29). The deck beam, with decking attached, has become dislodged from the bow and lays just below its former location.

Figure 27. Starboard side bow with outer hull planks, frames, breasthook, and dislodged deck beam and planking. Photo by Tamara Thomsen.

Figure 28. Bow construction.

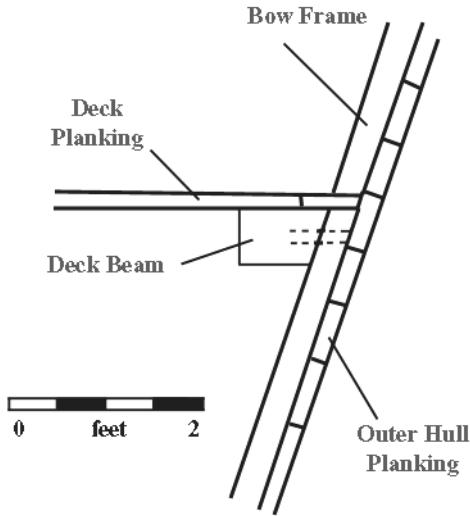
Figure 29. Deck / bow ramp interface.

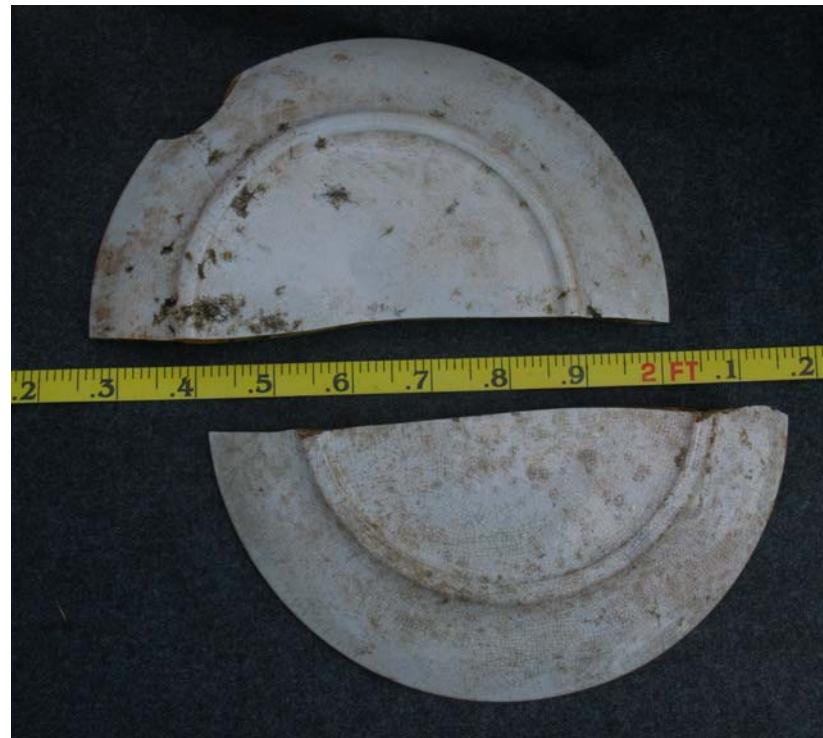
A collection of artifacts is accumulating on the cabin's roof through the actions of recreational divers who locate, excavate, and transport the artifacts to the cabin for display. A small coal shovel with an approximately 3 ft. long wooden handle was moved to the cabin from an unknown location; its handle was subsequently broken. Two whiteware plate fragments have also been relocated to the roof from an unknown location. The two plate fragments were brought to the surface for documentation and identification of any maker's marks, and immediately returned to the bottom (Figure 31). The fragments are two nearly equal halves from two separate plates measuring 9 in. in diameter. The plates had no maker's marks, and exhibited a large amount of crazing.

Figure 31. Underside of two plate fragments. Photo by Tamara Thomsen.

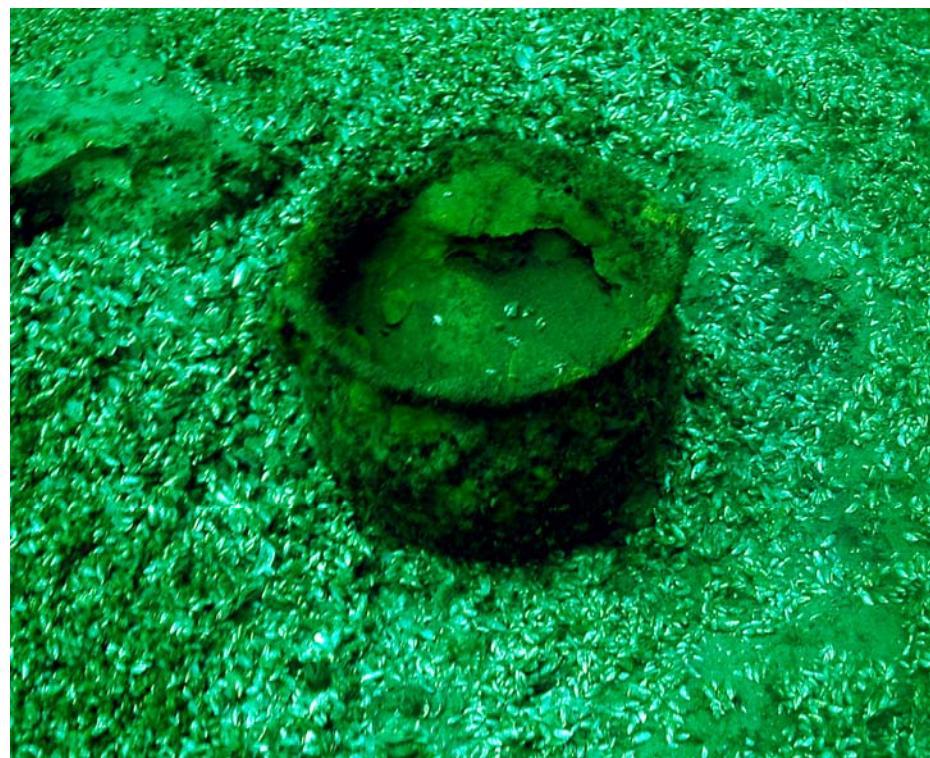
Two artifacts were found that had not been displaced. Twenty-seven feet off the transom's port chock, and fifty-eight feet from the boom's aft end, is a small cast iron cooking pot (Figure 32). The pot measures 1 ft. 9 in. tall and 9-5/8 in. in diameter. The pot is filled with silt and exhibits a large amount of surface corrosion. A two gallon, salt-glazed stoneware jug was located inside the bow (Figure 33). Resting atop a ceiling plank and leaning against the outer hull planks immediately to starboard of the stempost, it appeared as if someone had set it there just prior to abandoning ship. The jug was brought to the surface for documentation and identification of any maker's marks, and immediately returned to the bottom. The jug was marked with a "2" and a decorative pattern in cobalt blue. The jug's base was 6 in. in diameter with no markings. The circumference was 2 ft. 6-3/4 in. at the center, and 14 in. tall. The neck was 2 in. in diameter, chipped and angled slightly to one side. The stopper was missing and the jug was filled with mud. The jug's side had a shallow 2 in. diameter chip.

Figure 32. Cast iron cook pot. Photo by Tamara Thomsen.

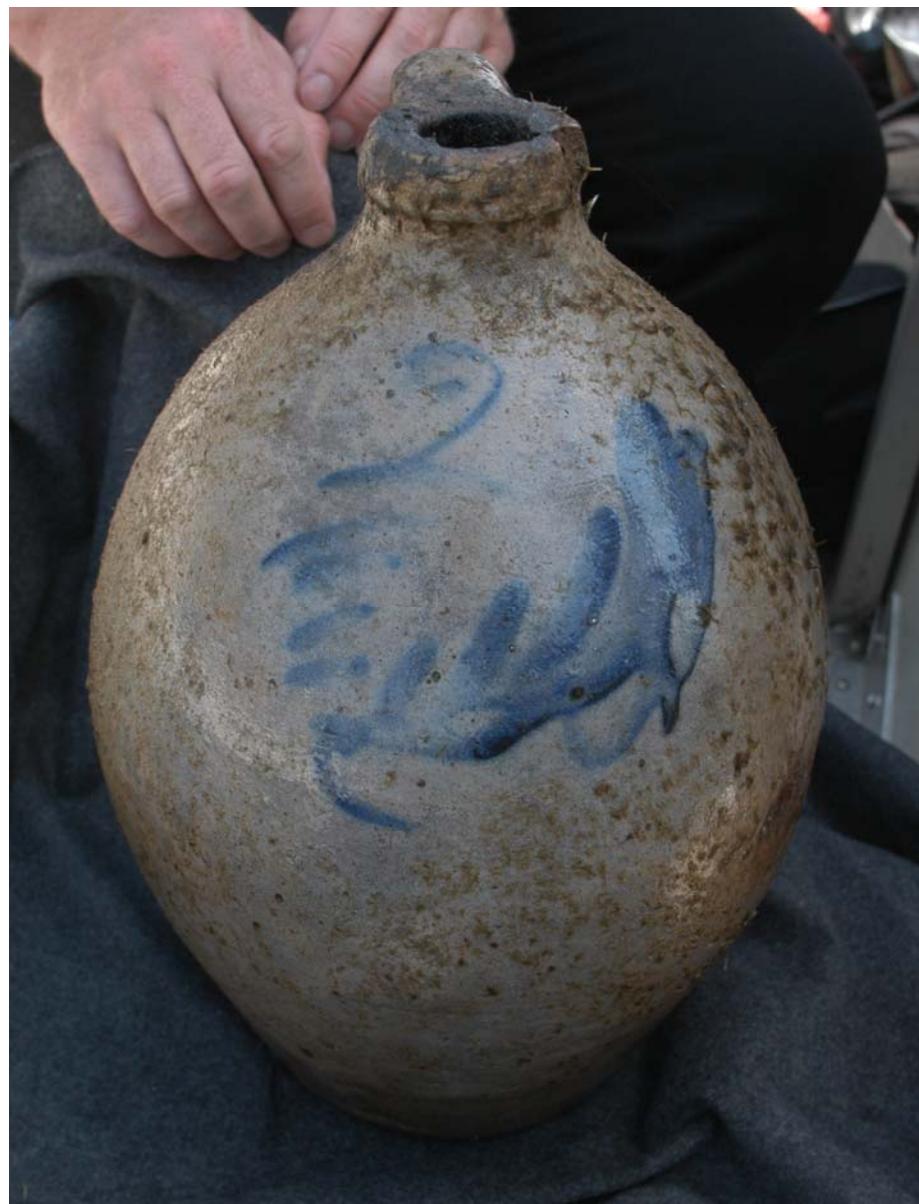
Figure 33. Two gallon stoneware jug. Photo by Tamara Thomsen.

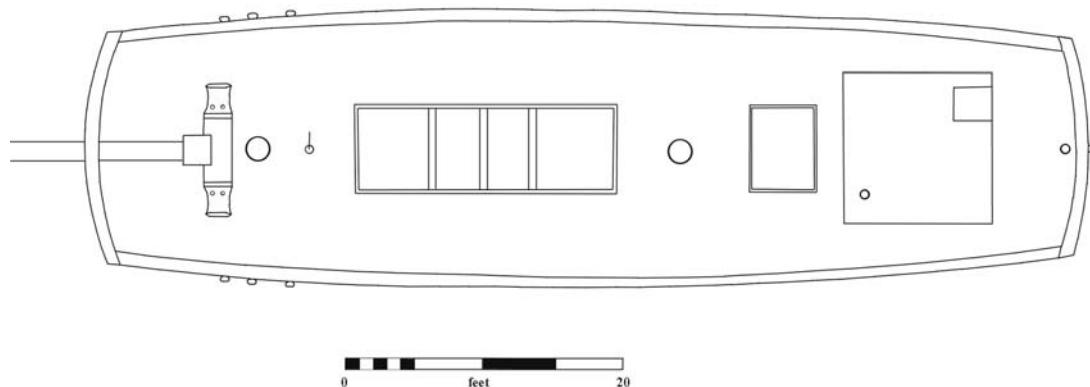
The *Ocean Wave* had an unusual deck layout with an elongated forward hatch (Figure 34). Not typical of Great Lakes sailing vessels, this large hatch must have been specially constructed for a specific trade or cargo, but it is not certain for what cargo or trade. It is unknown if the *Ocean Wave* was originally constructed with the elongated cargo hatch or if it was a later adaptation. It is equally unusual that the elongated cargo hatch would then be obstructed by three deck beams traversing its center. A large cargo hatch would have been more susceptible to leaking, or even crushing, from boarding waves. With the *Ocean Wave*'s low freeboard, boarding waves were probably not uncommon, and perhaps the deck beams supported the center of the cargo hatch. It is more likely they helped support the centerboard trunk, which was routinely subjected to large torsional stresses while underway. Further research into scow schooners and the stone trade may illuminate the elongated hatch's advantages.

Figure 34. *Ocean Wave* deck layout. Locations of masts, bilge pump, and forward cargo hatch are conjectural.

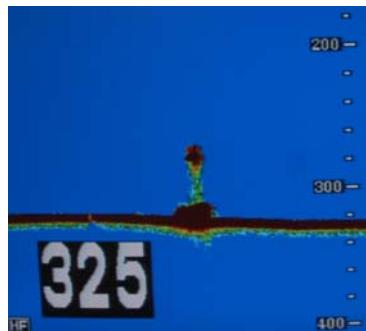
The *Tennie and Laura* rests upright on the lakebed at a heading of 070 degrees, sunk into the bottom to nearly her load line. At least one mast remains standing, rising to a depth of approximately 265 feet. No masts were recorded with the ROV, but the existence of a standing mast was obvious from the depth sounder images (Figure 37) and ROV footage of suspended rigging. The debris field off the starboard bow and beam is littered with a tangle of standing and running rigging. Wire rope lays in large tangles in the silt and a chain is visible lying on the bottom, either an

Figure 37. Sonar image of *Tennie* and *Laura* showing standing mast.
