**Myths and Mysteries:
Underwater Archaeological Investigation of the
Lumber Schooner *Rouse Simmons*, Christmas Tree
Ship**

**State Archaeology and Maritime Preservation Program
Technical Report Series #08-001**

Keith N. Meverden and Tamara L. Thomsen

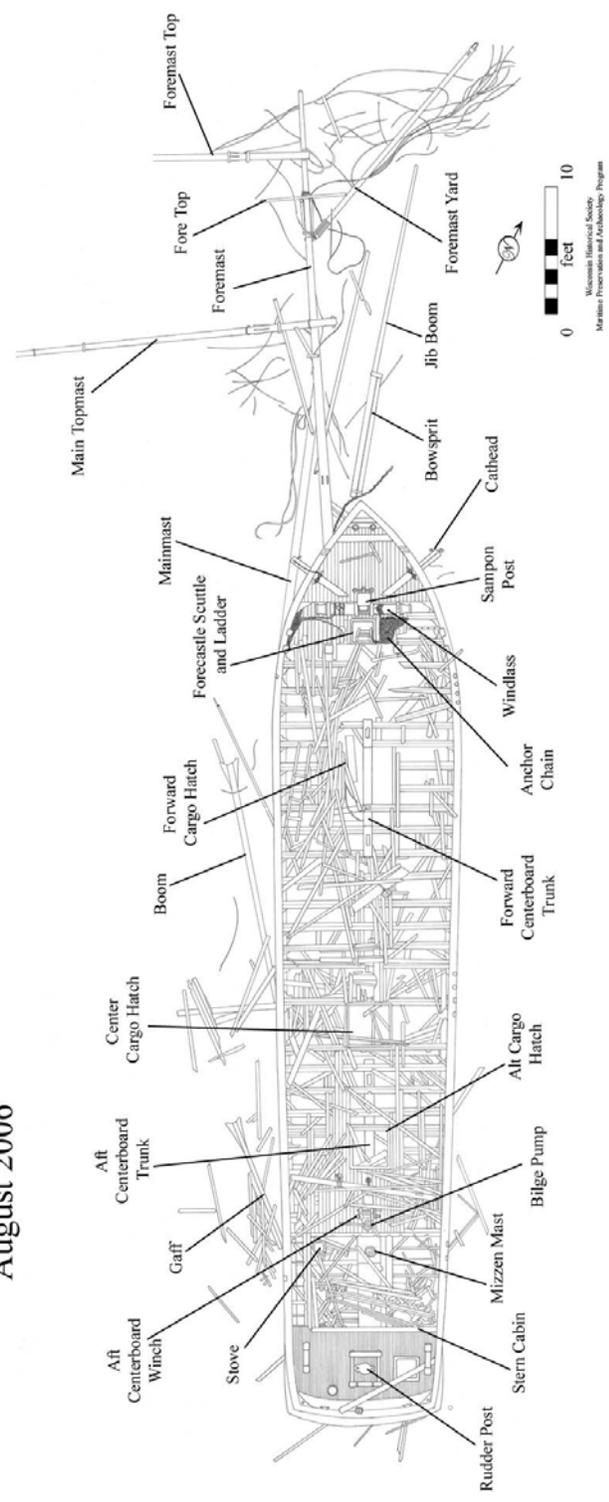
The *Rouse Simmons* lies on the lakebed on a heading of 330 degrees and is remarkably intact after sailing 44 years on the Great Lakes with an additional 94 years lying submerged on the Lake Michigan bottom. Despite being subjected to heavy salvage by recreational divers since its discovery in 1971, the *Rouse Simmons* site retains a wealth of information regarding double centerboard schooners specifically and nineteenth-century Great Lakes sailing vessels in general. Additionally, the site retains important clues about what happened during the *Rouse Simmons*' final moments.

Figure 6. *Rouse Simmons* site plan.

The *Rouse Simmons* lies on a mostly even keel, embedded in the lakebed to nearly her light load line with her weather deck resting at a depth of 153 feet. Most of the *Rouse Simmons*' hull is covered by zebra or quagga mussels that have colonized the wreck to a depth of approximately one inch. Few areas of the hull have not been colonized by the invasive mussels. The stern cabin is not extant and much of the deck planking had been dislodged, but nearly all other hull structures and rigging are either intact or present. The *Rouse Simmons*' cargo of evergreen trees remains in her hold and rises to within a few feet of the deck beams. All but the uppermost trees are buried by a dense layer of silt. The uppermost trees have lost all their needles, but trees more deeply buried in the silt still retain their needles. The wooden hull is largely devoid of paint with the exception of small patches in areas that have not yet been colonized by invasive mussels. On either side of the stem, small patches of green paint are visible with smaller traces of blue paint on top of the green, indicating the formerly green hull was repainted blue at some point before her loss. Following several survey dives, two divers discovered traces of bright yellow paint on their dive gear without a reason for its presence. While no containers of yellow paint were recorded during the survey dives, the divers who discovered paint on their gear were working beneath the deck near the forecabin.

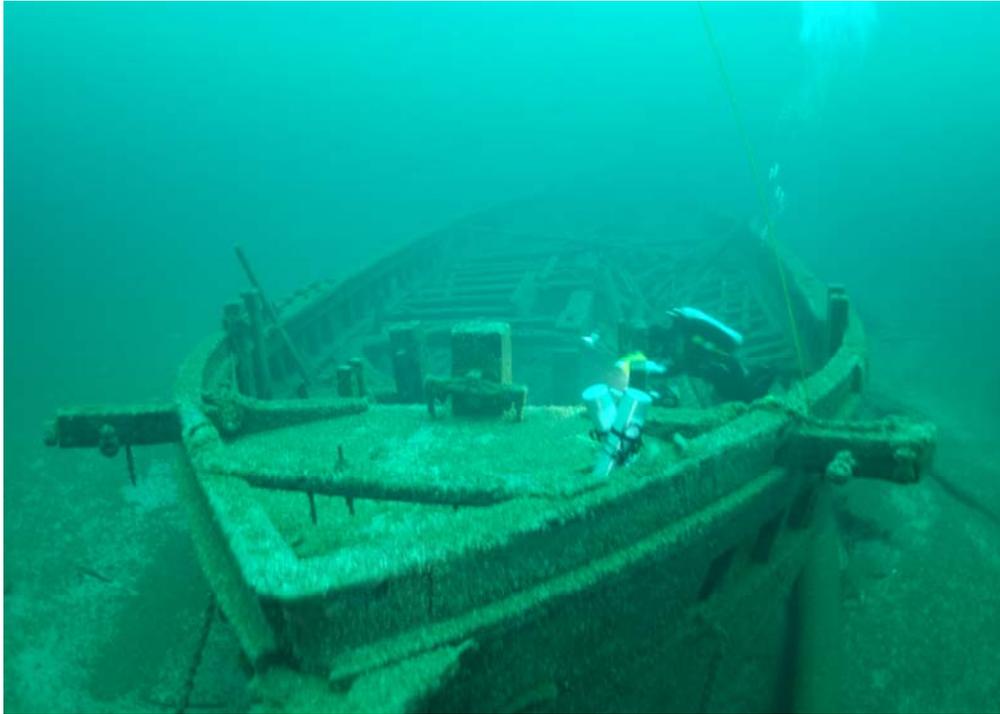
constructed of four planks .7 feet wide and rises .2 feet above the forecastle deck. Aft of the hearts is a pin rack that runs between the rails and measures 6.2 feet in length and .7 feet in width, with two iron pins extant in the rack (Figure 9). Two open chocks are fastened to the top of the rail on either side of the bow 1 foot aft of the pin rack. The chocks are cast iron and .2 feet wide by .2 feet tall and .5 feet long.

Figure 9. Forecastle deck with pin rack, catheads, samson post, and cross head visible.

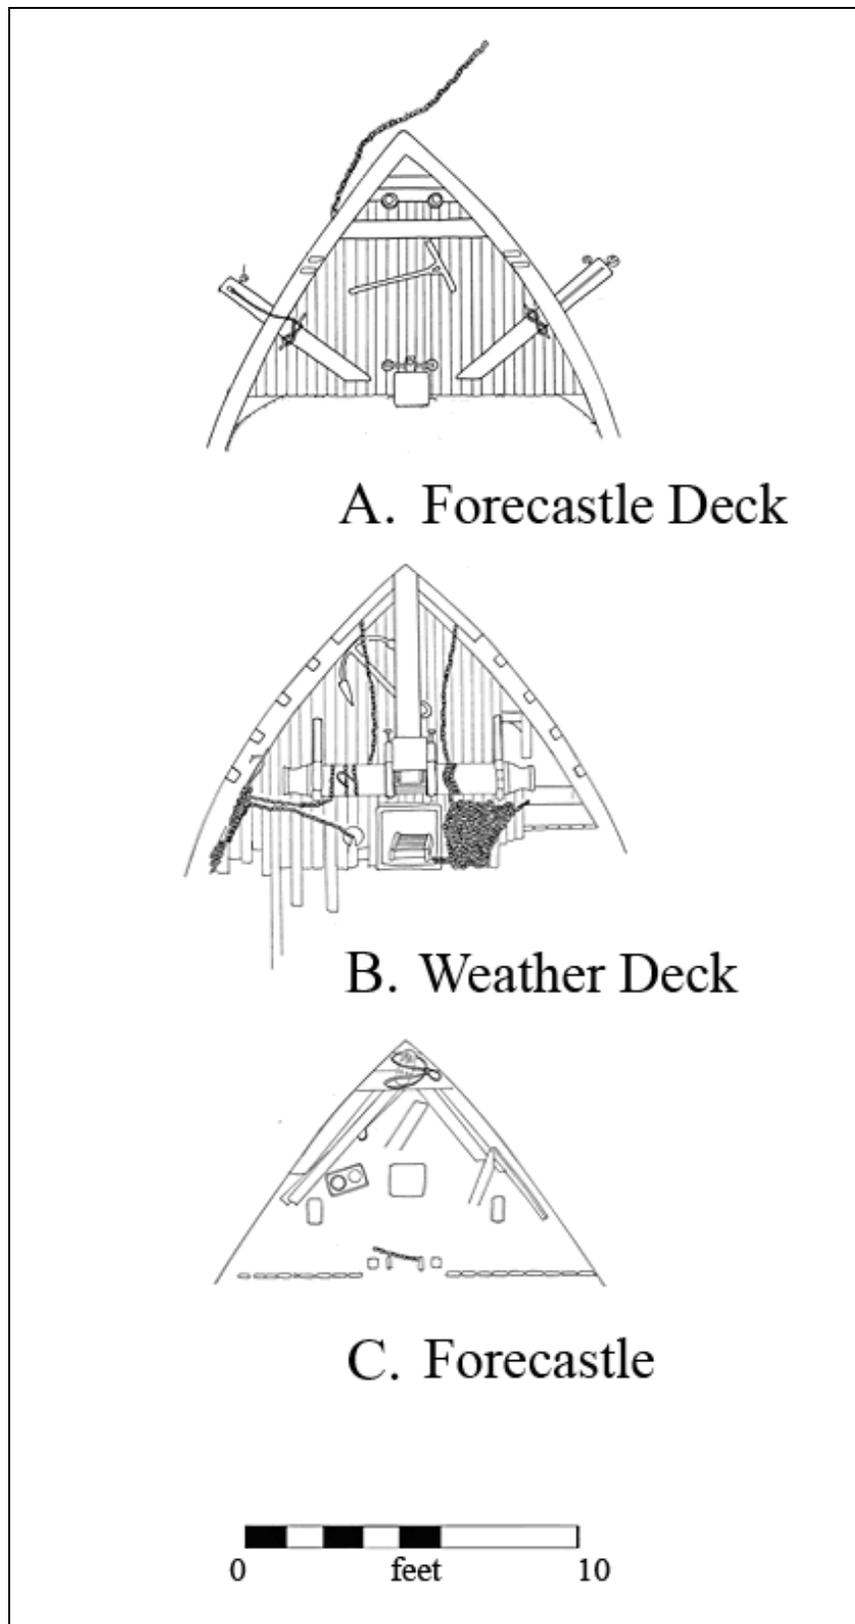
The forecastle deck is intact between the stem and samson post (Figure 10A). The top of the forecastle deck is 3.0 feet above the weather deck and supported by four

Figure 10. Plan view of deck levels at the bow.

The forecastle is a jumble of debris covered by a deep layer of fine silt (Figure 10C). There is a distance of 6.3 feet between the stem and the samson post, and only 4.0 feet of clearance between the silt and the weather deck. An unidentified piece of wire rigging lies in the forepeak that consists of a served wire eye wrapped around a cylindrical timber. This artifact lies on a small wooden shelf constructed of 3 of athwartship planks that are .7 feet wide by .2 feet thick. On either side of the forecastle are several dislodged planks that vary in width from .7 feet to 1.0 foot and are several feet in length, perhaps the remains of crew bunks or shelves for the boson's gear. A two burner wood cook stove lies on the port side floor (Figure 16). Both burners are .6 feet in diameter, and the outboard burner has a ring to hold pots on the burner plate during heavy seas; the inner burner does not. The stove is 2.0 feet long, 1.2 feet wide, and 1.0 foot in height. A leather shoe lies forward of the stove, and an unidentified article of

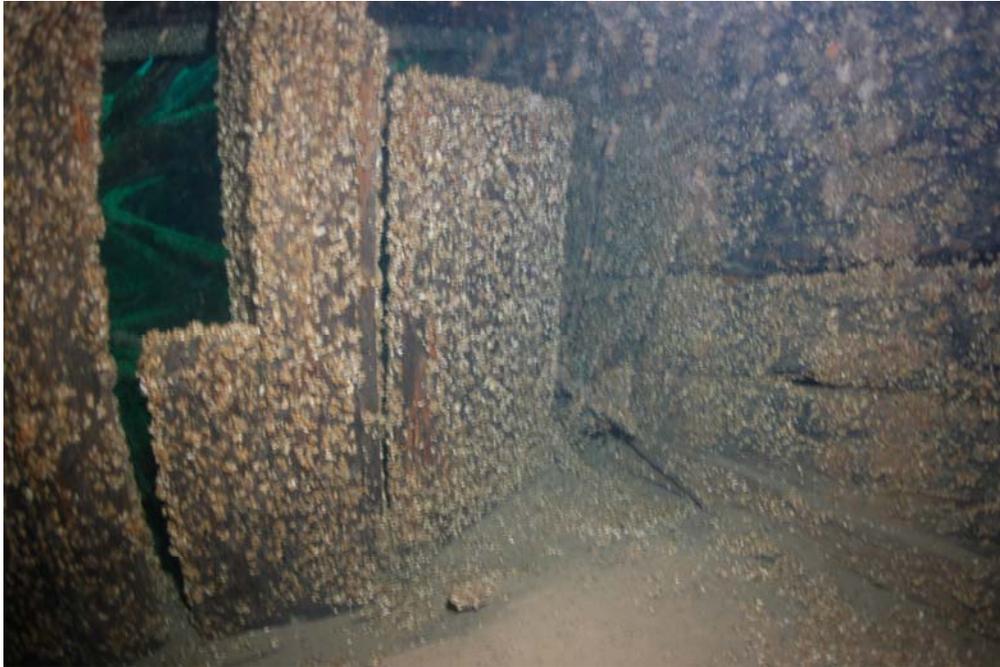
Figure 15. Port side bulkhead and door between the forecastle and cargo hold, looking aft.

A wooden bulkhead separated the forecastle from the cargo hold. Constructed of vertical planks .2 feet thick and .7 feet wide, 3.0 feet of the bulkhead is visible between the weather deck and the sediment at the bottom of the forecastle. Nine bulkhead planks are extant to starboard of the forecastle ladder. To port of the ladder, 4 planks are extant between the ladder and a door frame that is .2 feet wide. The frame houses a small door constructed of three vertical planks that are 1.8 feet wide and 3.0 feet tall (Figure 15). There is a gap between the door and the weather deck, and it could not be determined how the door was hinged and fastened. One additional bulkhead plank is extant between the door and the port side hull. The forecastle bulkhead is not continuous from port to starboard, but terminates on either side of the forecastle scuttle. Much of the area abaft of the forecastle scuttle is heavily damaged, making it difficult to determine how the bulkhead was constructed in this area.

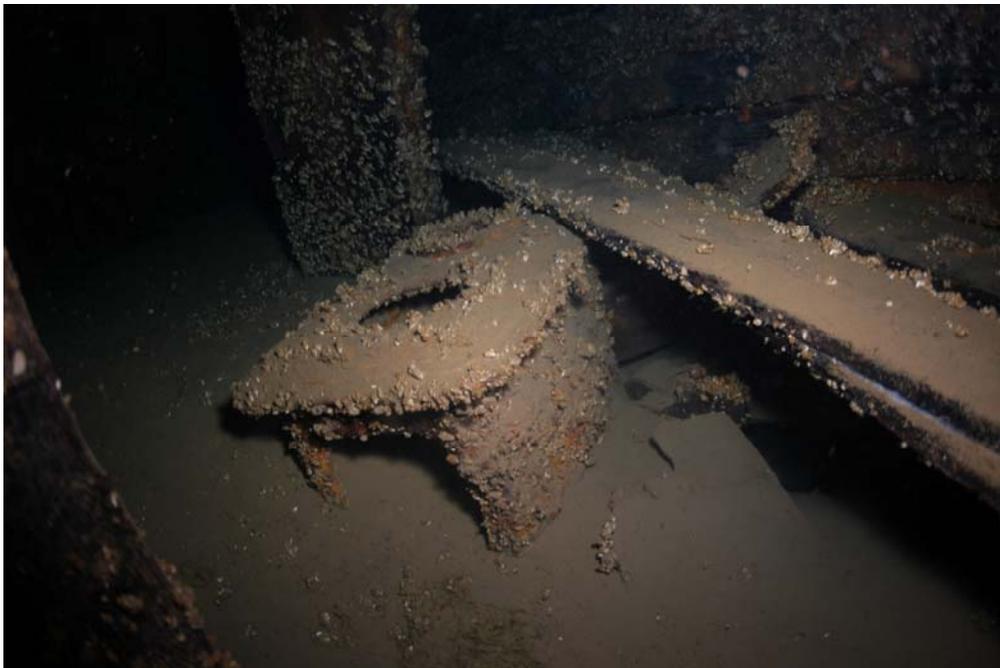
Figure 16. Wood cook stove in forecastle.

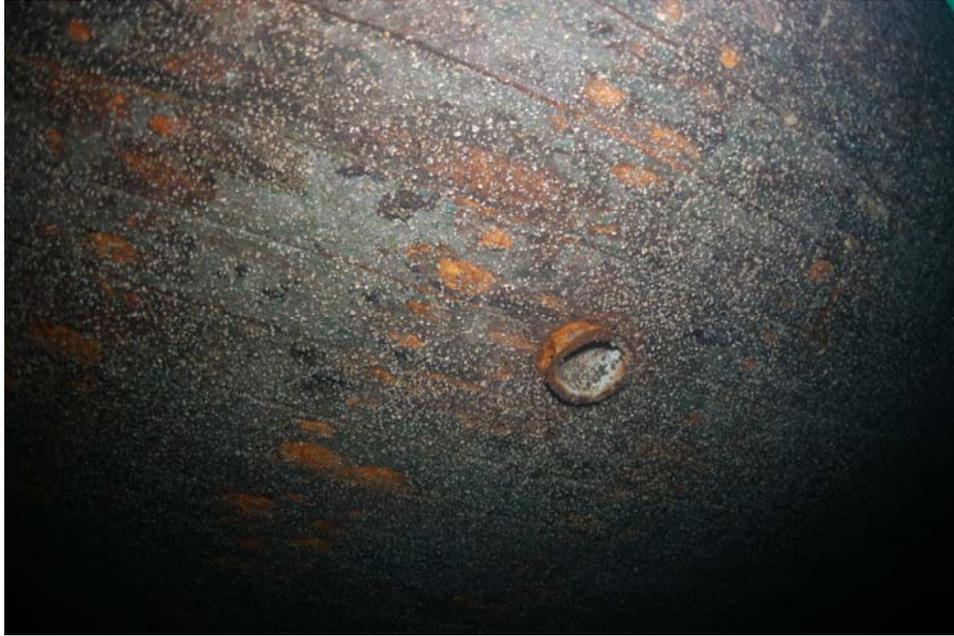
Figure 21. Through-hull fitting beneath the cabin's starboard quarter. Blue hull paint is visible on much of the planking.

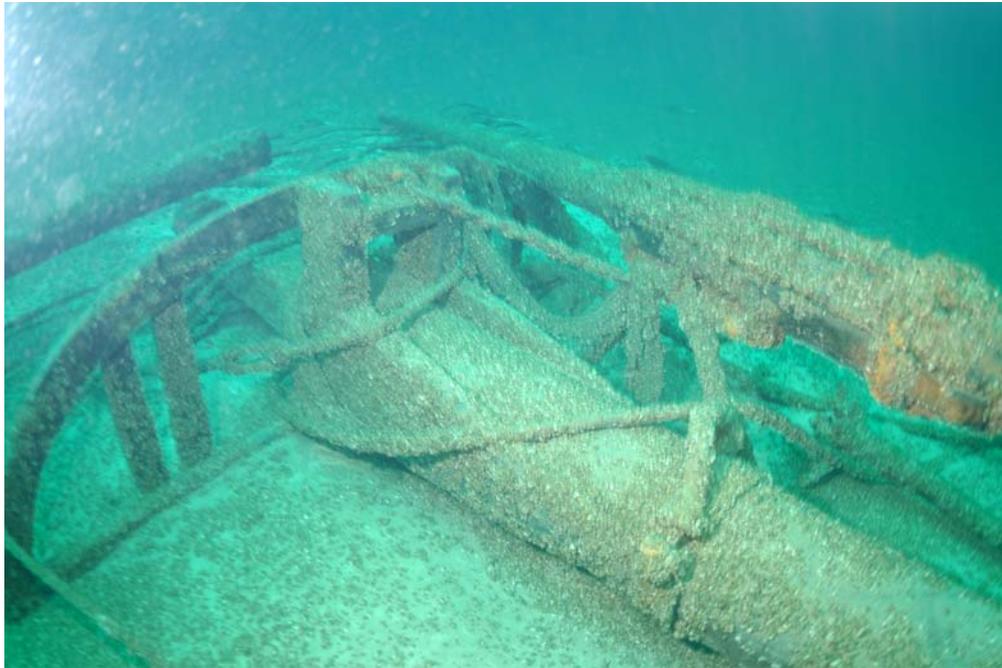
The futtock band is located 56.8 feet above the heel and is tightly fitted around the mast. The futtock band is constructed of iron and served as an anchor point for the yard truss in addition to providing support for the cheeks (Figure 24). The yard truss is a gimballed iron truss fastened to the front of the futtock band that held the only yard carried by the *Rouse Simmons*. The yard was 67.3 feet in length and was most often used to set the raffee sail, a triangular topsail common on the Great Lakes, but could also have been used to set a fore course. The yard truss is intact, although somewhat bent, and is supported by a chain sling. The yard is broken to starboard of the truss, and the yard's starboard half lies beneath the foremast closer to the hull. The detached starboard section is 32.0 feet in length, .67 feet in diameter at the break, and .5 feet in diameter at the arm. An iron hoop is fastened to the yard arm's bitter end that forms an elongated eye. A brace block is attached to the yard via an iron brace pendant 4.0 feet

Figure 24. Foremast with top, trestle trees, cheeks, futtock band, truss, sling, and yard visible.

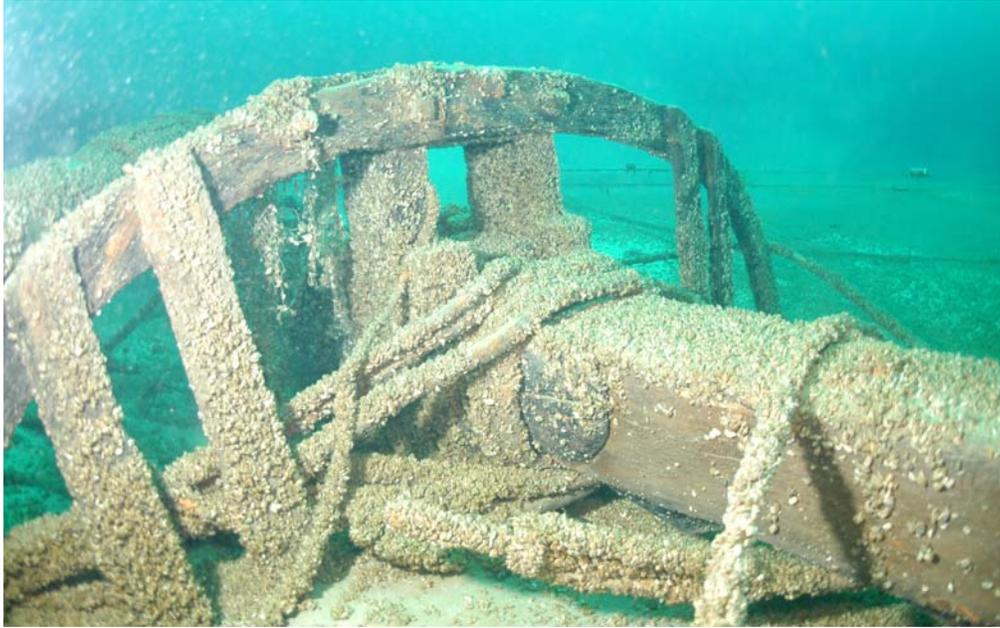
Frequently misnamed the crow's nest, the top is fastened above the trestle tree along with two hardwood bolsters and battens (Figure 25). Located 6.0 feet above the futtock band and 12.9 feet in width, the rim of the top is fastened to the trestle tree with iron bolts, and its primary purpose was to provide a platform for working the raffee and topsails. The foremast top's forward edge is swept aft to cut down on weight aloft as

Figure 25. Foremast with top, trestle trees, bolsters, and battens, viewed from above. Note shroud eyes still attached to mast.

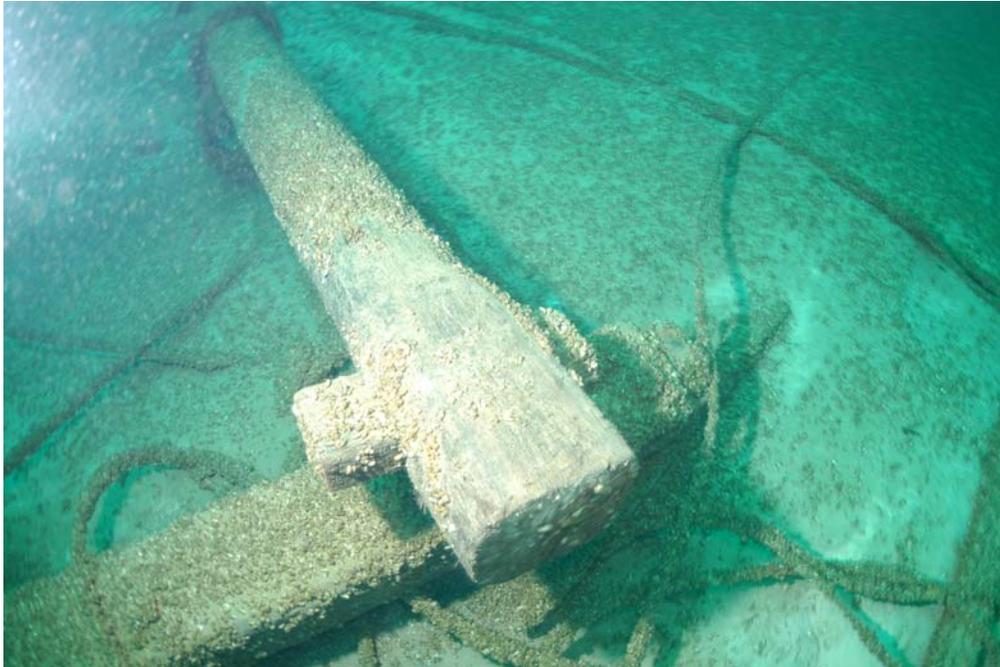
The mast is square in section from the cheeks upward, and rises 9.0 feet from the top of the cheeks to the masthead. A tenon 1.0 foot long by .9 feet wide is cut into the top of the masthead to accept the wooden mast cap. The fore topmast was stepped forward of the foremast, but is dislodged and now lies near the masthead at a perpendicular angle to the foremast. The fore topmast is intact, but the top of the foremast is buried in the lakebed; the measureable length is 30.0 feet. The topmast is circular in section with the exception of the heel, which is squared to fit into the trestle trees. The topmast was kept from dropping through the trestle tree by a wooden fit that remains in place at the bottom of the topmast (Figure 26). The heel of the topmast is .9 feet by 1.1 feet in dimension. The wooden foremast cap is intact on the topmast and is located 8.5 feet from the bottom of the topmast (Figure 27). The mastcap is .25 feet thick and is mortised 1.0 foot by .9 feet to fit the tenon at the fore masthead. A topsail saddle is located above the mast cap. The topsail saddle is constructed from four wooden chocks affixed around the topmast that begin at 9.9 feet above the heel. An iron band is tightly fitted over the top of the chocks and is located 11.2 feet above the heel. At 22.0 feet above the heel, the topmast's diameter is .9 feet.

Figure 26. The base of the fore topmast with intact fid. The mast cap visible at the top of the image, which fit onto the tenon at the masthead beneath the topmast.

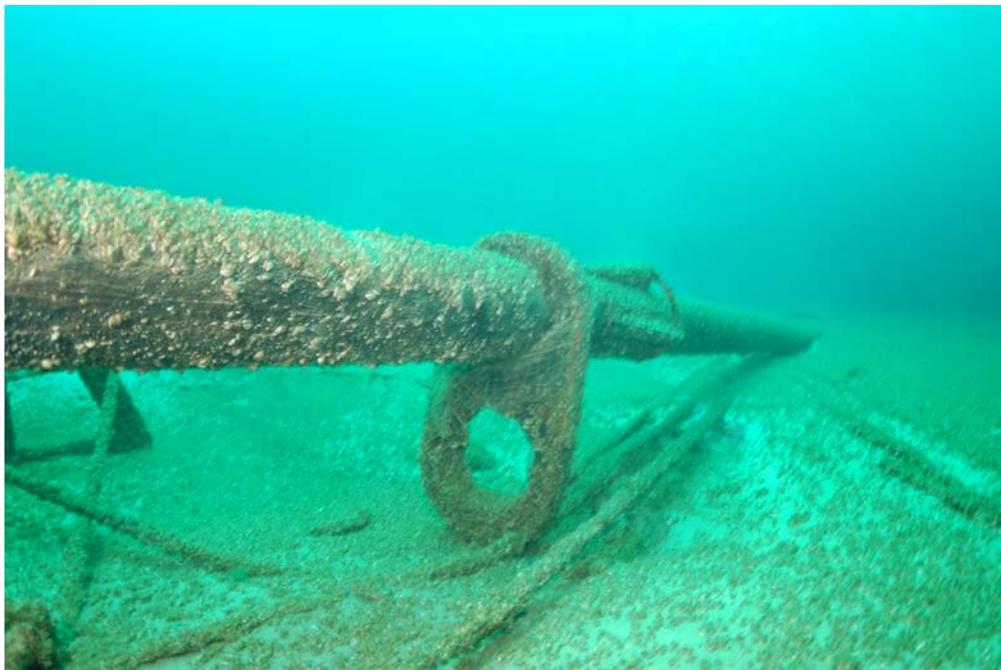
Figure 27. The foremast cap is intact on the fore topmast. The topsail saddle is visible above the mast cap. Topmast shrouds are visible beneath the topmast.

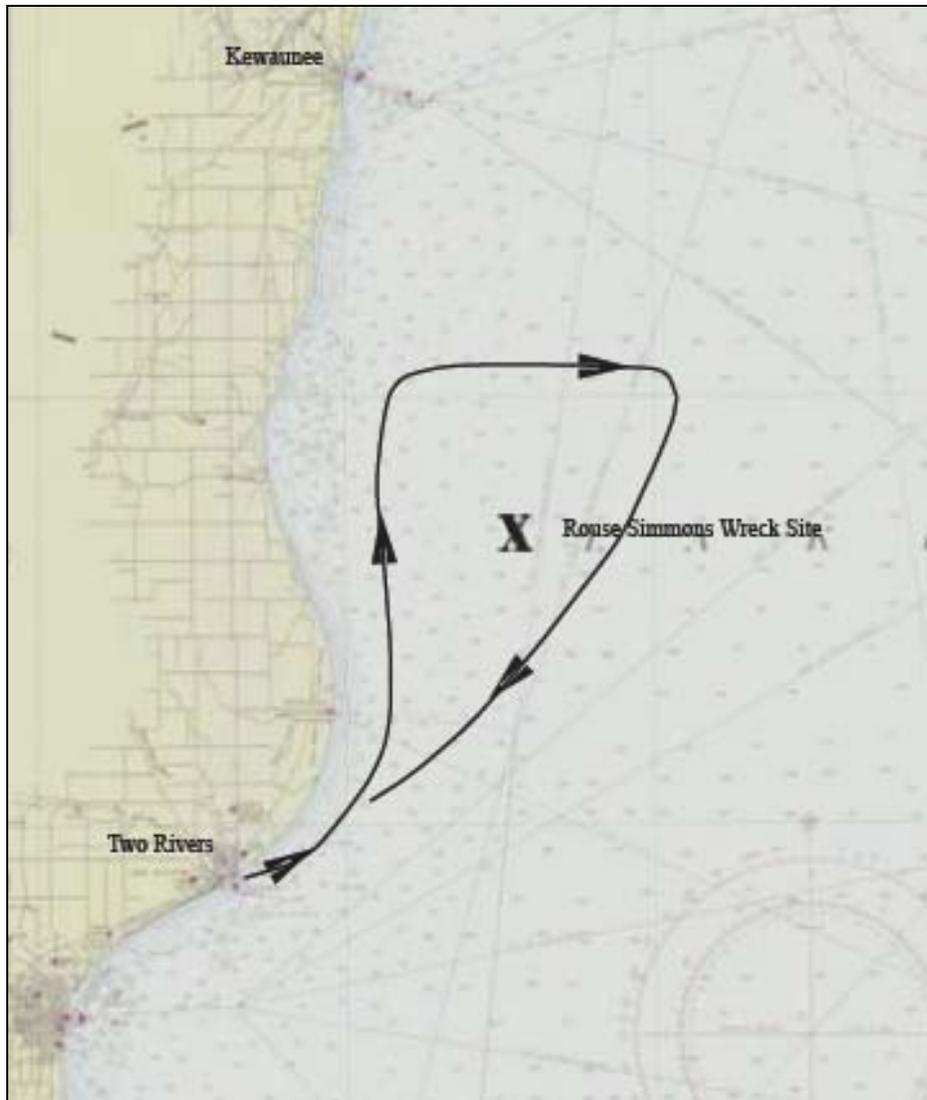
Combining Captain Sogge’s logbook entry with his later statements, the lifeboat’s approximate search pattern was recreated (Figure 29). It was presumed the Life-Saving crew took a direct route back to Two Rivers after ending their search. The recreated route, superimposed over the location of the *Rouse Simmons*’ wreck site,

shows that the lifeboat's search pattern completely encircled the *Rouse Simmons*. With visibility reaching nearly to Kewaunee when the search was commenced, the lifeboat crew should have seen the *Rouse Simmons* as they rounded Two Rivers Point. Even if they were unable to see the *Rouse Simmons* when the search commenced, they should have encountered her at some point during their search. Given that the lifeboat crew saw no trace of the vessel, it is likely that the *Rouse Simmons* was already on the bottom when the lifesaving crew rounded the point at 4:20 P.M., a little over an hour after her sighting by the Kewaunee Life-Saving Station.

Figure 29. Recreated search pattern of the Two Rivers Life-Saving crew with the location of the *Rouse Simmons* today.

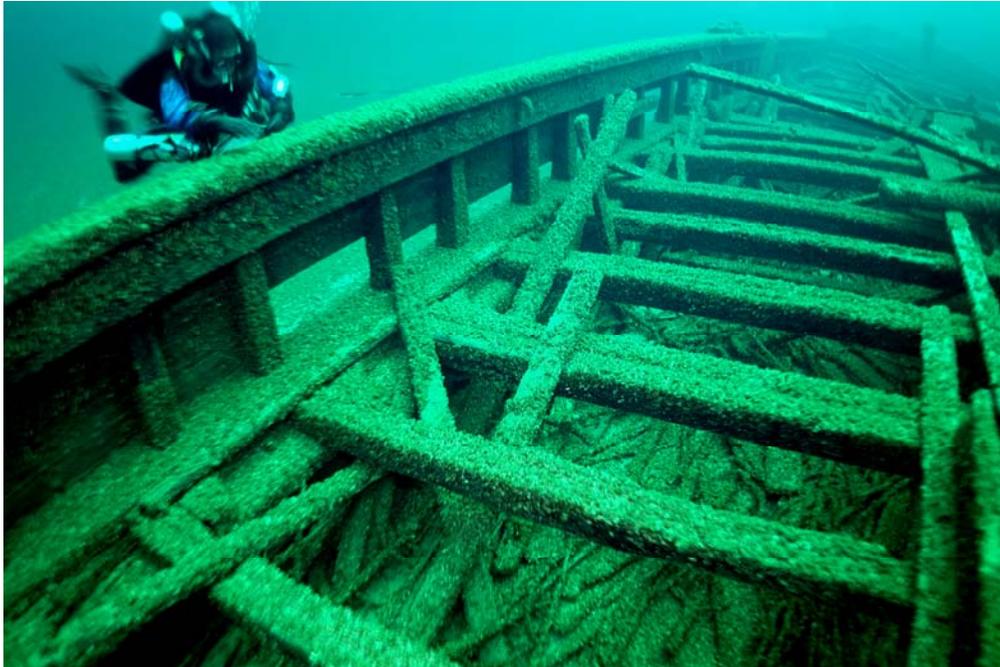
The question remains, why did the *Rouse Simmons* sink? It will never be known for sure, but it was more likely due to an old, worn out vessel that was past her prime more than any other factors. The deck beams may hold one clue. A close examination of the deck beams revealed salt channels carved into the top of each (Figure 33). These channels were filled with salt prior to installation of the deck planks and served to pickle the deck beams to prevent rot. Impregnating the beams with salt would also have had a detrimental effect on the integrity of the iron nails that fastened the deck planks, and may have resulted in loosening of the deck during the storm. Very little of the deck is intact, unlike similar vessels in Wisconsin wrecked at similar depths. Missing deck planks may have let more water into the hull than the pumps could remove.

Figure 33. Salt channels carved into the top of each deck beam.

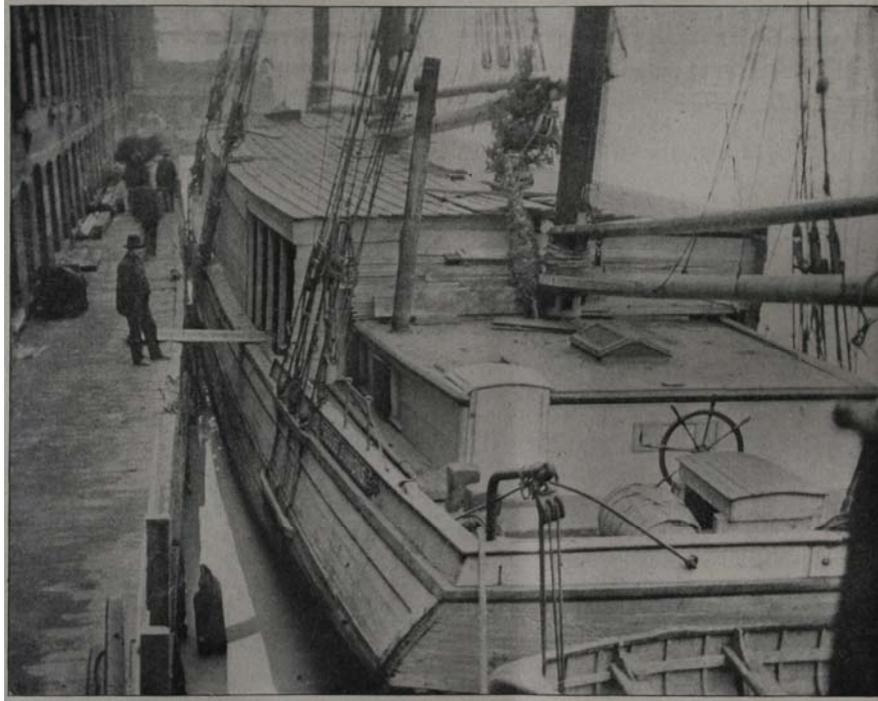
There may be another reason the *Rouse Simmons* is missing so many deck planks. Several contemporary newspaper accounts described the existence of a deck house that was installed by Captain Schuenemann. The archaeological survey of the hull did not discover any evidence of a deck house, and it was presumed that the newspapers had confused the deck house with that of the *George Wrenn*, a schooner used by Schuenemann prior to the *Rouse Simmons* on which he had installed a large deck house (Figure 34). It wasn't until maritime historian Ron Beaupre uncovered a rare image of the *Rouse Simmons* that was published in the *Marine Review* in February 1913 (Figure 35) that the existence of the *Rouse Simmons*' deck house was confirmed. In the image a crude deck house is shown between the foremast and the stern cabin. Did Captain Schuenemann consider the deck house seaworthy enough to forego installation of the hatch covers prior to packing the deck house with evergreens, or were some of the weather deck planks removed and used to construct the deck house? This would have allowed a small increase in cargo capacity but would have left the vessel extremely vulnerable to swamping. The deck house's roof was lapstrake planked,

Figure 35. This rare image may be the last ever taken of the *Rouse Simmons*, and confirms the existence of the deck house (Marine Review 1913).

and the sides of the house are so poorly fitted it is doubtful the cabin was watertight. Given that no evidence of the deck house was found on the hull, its framing was obviously equally as poor as its planking.
